# COMMERCIAL BUILDING SURVEY

**Berkshire**

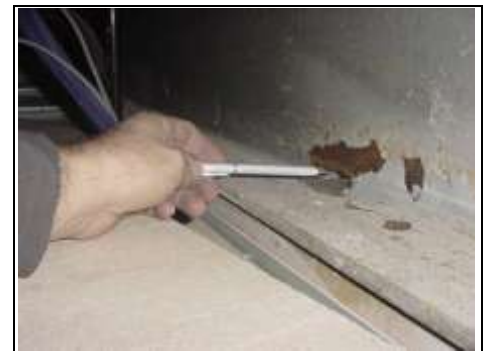
Our main concern is rusting that we can see within the structural frame. Whilst the rusting seen isn't of such a condition that we believe it will cause structural problems it does mean that there may be future issues.

Rusting to frame

**ACTION REQUIRED:** Open up structure to establish condition of structural frame and carry out sonic testing or similar to confirm the condition of the structural frame.

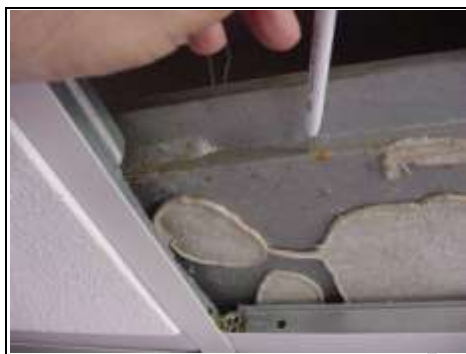
The metal frame that is holding up the property is showing signs of rusting and also specks of rust. Whilst we had a very limited view of the structural frame, where we could see it, which was via the removal of part of the suspended ceiling, we noted rusting and specks of rust. Our concern is that an important section such as the junctions and ground floor level there may be further rusting that needs repair and or replacement.

Rust spots to frame

**ACTION REQUIRED:** The entirety of the metal frame needs further investigation and checking in the vulnerable areas as far as possible. We would recommend specialist testing on the structural frame. We would also like to see further evidence that fire protection has been applied to this structural frame (as well as paperwork).

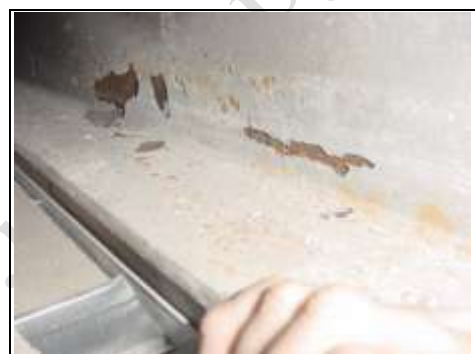
General rusting

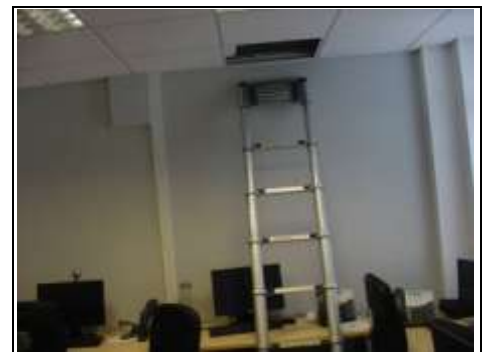
Access was awkward and difficult and was via a suspended ceiling tile. Proper access needs to be set up for a full investigation.

**ANTICIPATED COST:** If there are major problems within the structural frame then £20,000 - £50,000 would be the cost range that we are looking at. Testing of the structural frame is likely to cost a few

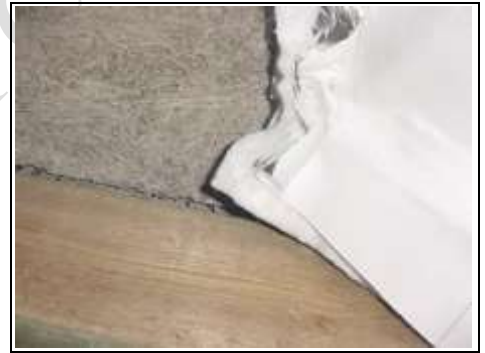
Wood wall slab

Wood shavings/straw that is cemented together into slabs. Unfortunately the slabs have little strength when damp meaning they are not an ideal material to be used for roofing which is what they were commonly used for!

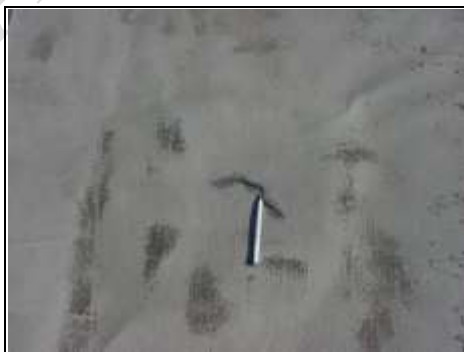
Deterioration to the felt

**ACTION REQUIRED:** We would recommend re-roofing and that insulation is added with a high performance felt and a fall added to the entire roof. At the same time we would build up the firewalls internally.

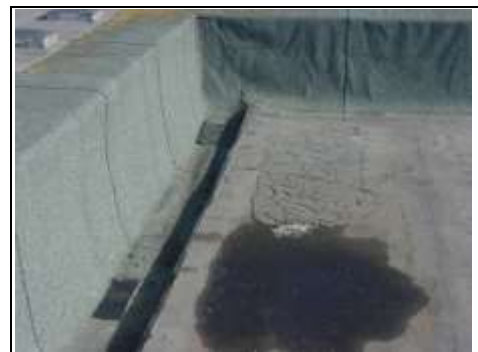
Ponding to the roof indicating low areas. Also crocodiling/crazing visible to the surface of the bitumen repair

This is not ideal on a flat roof as it indicates a low point that over time with the weight of water on this point will cause further defects

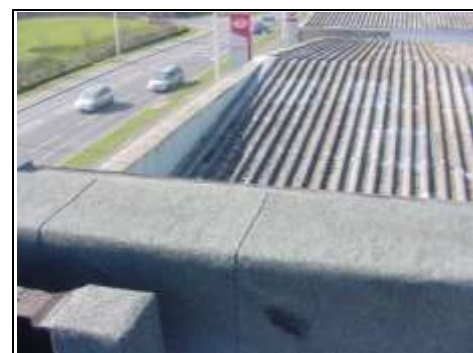
It is never ideal to have an asbestos roof. In this case it is very difficult as this is also forming part of your neighbour's roof.

Asbestos Roof

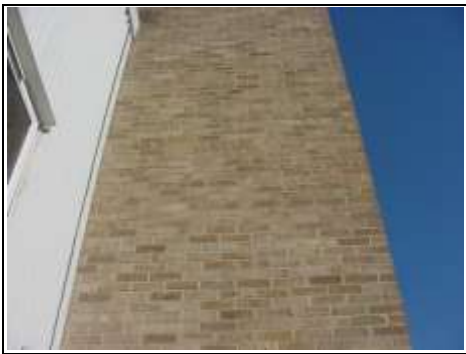
Hidden from view to the rear left hand gable of the property and visible from the fire escape is a raking crack. Whilst this property sits on a structural frame, nevertheless we would always recommend monitoring of such cracking to see whether it relates to other problems with the property, possible movement to the adjacent property or water getting into the structure.

Brickwork to left hand gable

**ACTION REQUIRED:** Existing owners to place an insurance claim that you could then take over which should limit your liability to the premium provided the paperwork is carried out correctly. We would recommend that your Legal Advisor verifies that all paperwork is in place in relation to the cracking before you legally purchase the property.

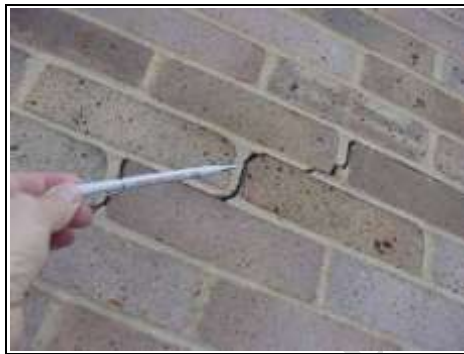
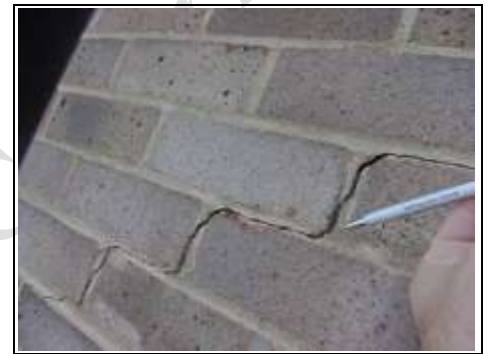
Cracking to left hand side

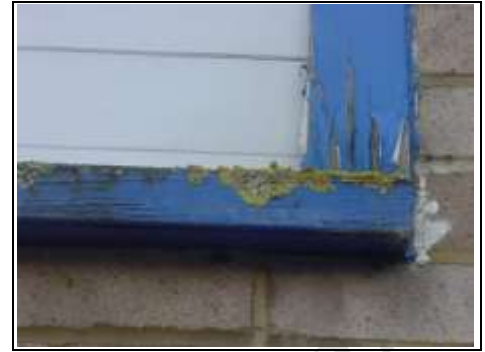
Generally the external joinery has seen its best days and we could find areas of rot in a percentage of the low level timber. Typically high level timber is more affected.

Rot to windows

**ACTION REQUIRED:** We would recommend replacing the timber windows and the panels with double glazed units. It is more typical to have powder coated aluminium in this style of building.

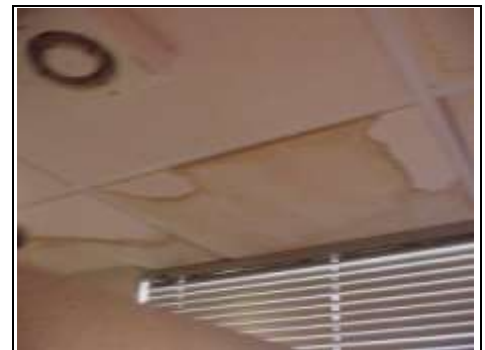
There are many areas within the toilets where there is staining to the ceiling. We assume this is from leaks from above or possibly even via the windows by wind driven rain. We would expect the replacing of the windows and the external joinery to resolve this however there will still be a need to replace the ceiling tile.

Water staining in gents toilets

**ACTION REQUIRED:** Replace ceiling tiles.

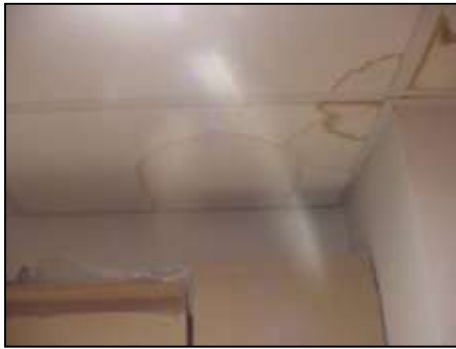
Water staining in ladies toilets

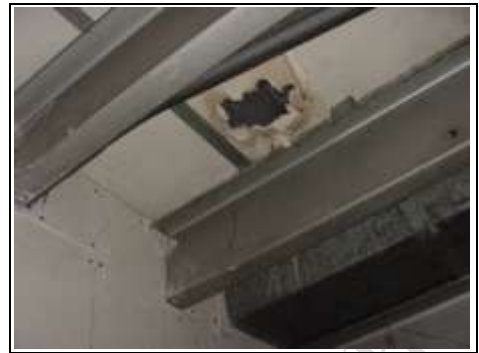
There is a water leak to the store on the left hand side which possible relates to the box gutter we mentioned earlier.

Water leak in store cupboard

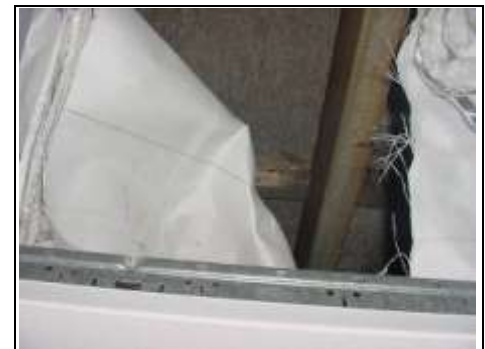
We also noted that around the staircase, which should be a protected area, as in a worst case scenario it acts as an escape route, that the fire blanket (Proprietary name Firefly Plus) was not fitted properly. This means that fire could transfer from floor to floor.

Firefly Plus paper that isn't fitted properly

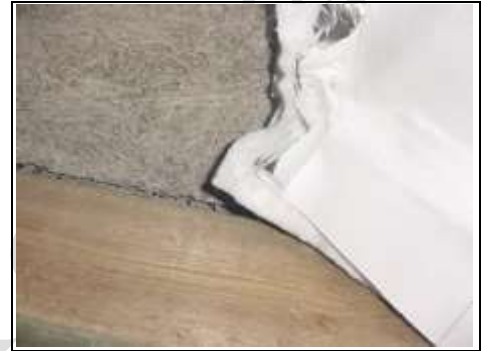
Wood shavings/straw that is cemented together into slabs. Unfortunately the slabs have little strength when damp meaning they are not an ideal material to be used for roofing which is what they were commonly used for!

Wood wall slab

**ACTION REQUIRED:** We would recommend an insulation is added and a high performance felt.

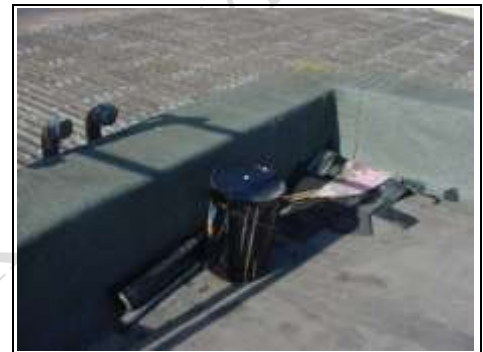
The parapet wall is covered with felt. We assume they have been problematic in the past. Our photo shows a parapet wall covered with felt and also tar and various other repair materials which are not ideal to seal a flat roof!

Parapet wall

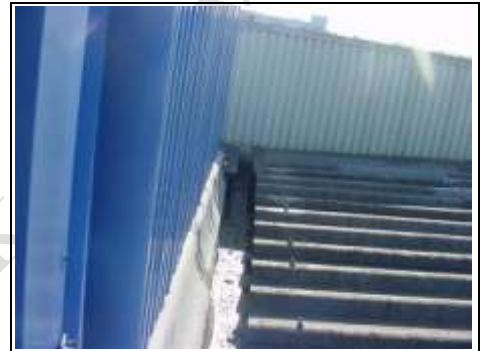
There is an asbestos roof to the left hand side which is over the fire escape and the store. Ideally we would recommend getting rid of any asbestos however in this case it would be difficult as the asbestos roof that goes over your staircase and store areas on the left hand side also forms the roof of the adjoining property. We assume that some sort of agreement has taken place to buy this section of next doors property.

Asbestos sheets covering area

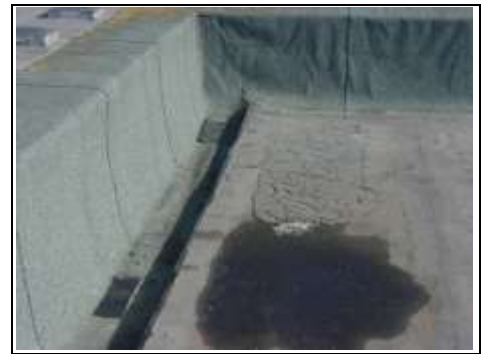
Typically we find with flat roofs that the falls on the roof aren't sufficient to put the rainwater to the outlet openings and you get ponding on the roof as we have found in some areas in this case.

Ponding to roof

**ACTION REQUIRED:** We would recommend general cleaning of the outlets

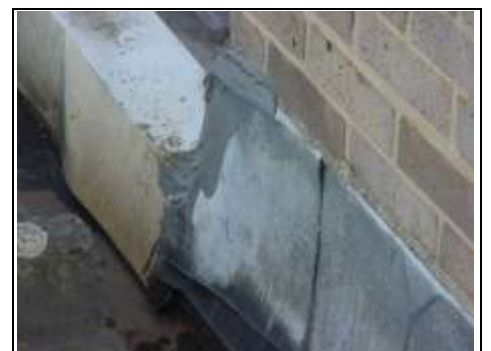
You have a box gutter to the left hand side where this property meets the next property. Please see our comments earlier on in this report with regard to repairs needed. We could see that repairs have been carried out so we assume there have been leaks in the past.

Old repairs to guttering

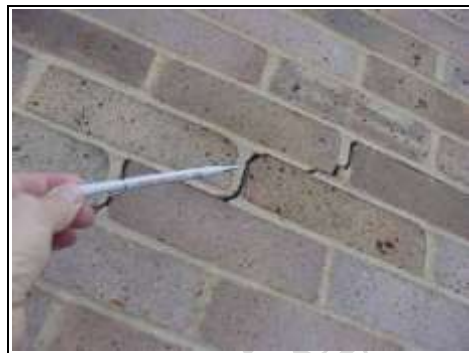
Cracking to brickwork

**ACTION REQUIRED:** Please see our comments in the Executive Summary. You need to have an insurance claim placed by the existing owner.

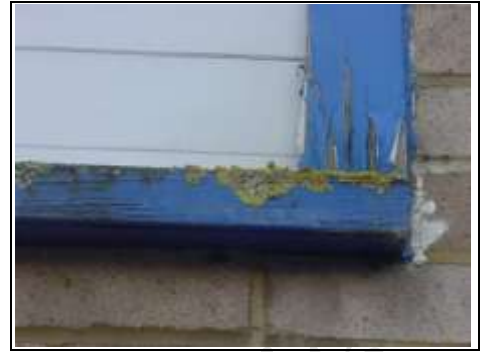
Rot to windows

**ACTION REQUIRED:** We would recommend replacing the timber windows and the panels with double glazed units. Please see our comments in the Executive Summary.

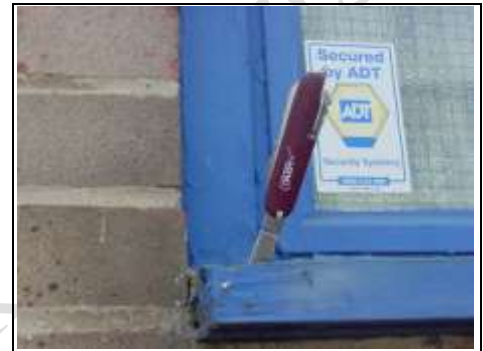
Knife test to windows

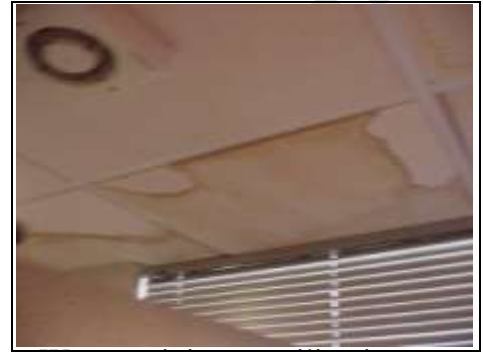
There is water staining in many areas around the toilets which we believe may relate to leaking soil and vent pipes, water spillages, etc.

Water staining to ceiling in gents toilets
