COMMERCIAL BUILDING SURVEY

London Borough of Barnet

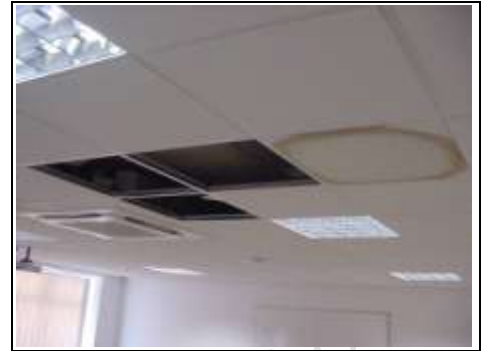
They kindly escorted us and showed us the problems that they have had within their building. This included the ceiling tiles down within their training room that was being affected by the dampness still, even though they had a roofer carry out various repairs on the roof. Unfortunately the roof problem has been relatively persistent over the time they had owned the building.

XXXXXX Ltd have problems with the roof causing ceiling tiles to be stained and deteriorate

In our experience, where you get a leak with an asphalt roof, it is very difficult to find out where it is coming from without using very specialist equipment and of course you would have to remove all the decking.

ACTION REQUIRED AND ANTICIPATED COST: As mentioned, we have had a very limited view of the roof but bearing in mind the problems that have occurred next door we would recommend that you put aside the sum of £5,000 to £10,000 for the possible removal of the entirety of decking, a full test and report of the surface (you can use dye tests and also electronic testers) and most importantly, you get a full guarantee from the developers for at least twelve months.

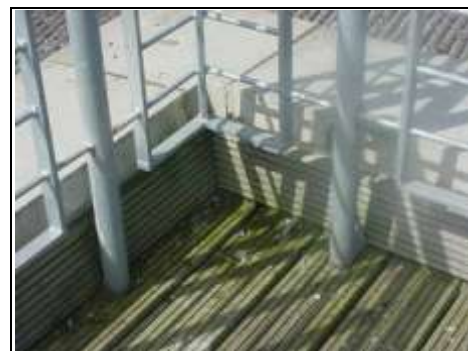
Coping stone and timber roof decking

We checked areas of the coping stone and noted that the drip detail is very close to the main wall. This could be an additional problem that is causing dampness coming through the property.

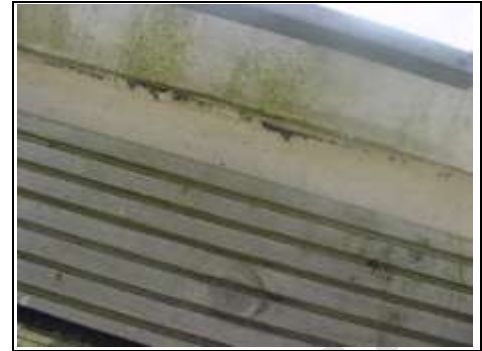
We can see moss in some areas.

Moss can be seen on parapet wall

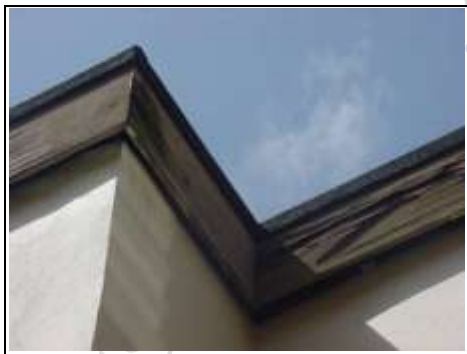
1. Next to the care home we could see a fascia board that is deteriorating indicating that dampness is getting in.
2. We can also see what looks to have been render repairs carried out at high level

Deteriorating fascia board

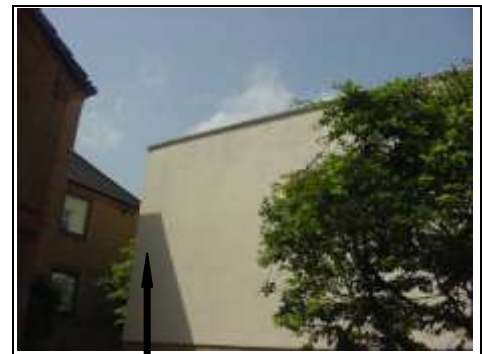
Possible re-rendering / repair work at high level (it does not show up very well in this photo)

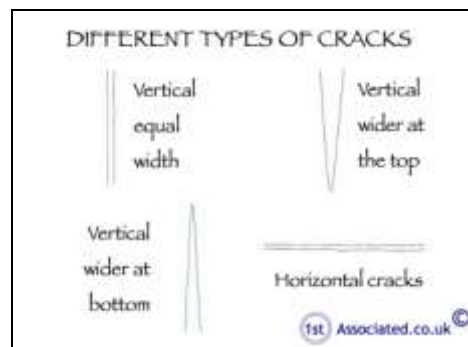
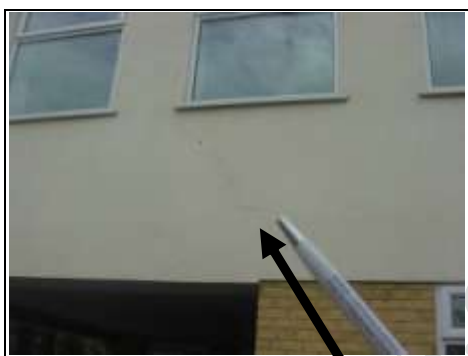
There are a variety of different types of cracks to the external of the building; vertical, horizontal and raking. Internally the cracks are predominantly vertical equal width.

We believe the cracks relate to a number of things. They are initial settlement as discussed, but we also believe that the building is suffering from the amount of dampness coming into the roof.

Vertical cracking to front

ACTION REQUIRED AND ANTICIPATED COST: You need to seal the cracks as soon as possible with suitable mastic. In the long term there are two alternatives available.

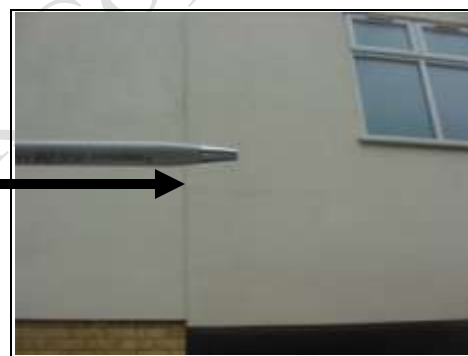
Horizontal cracking

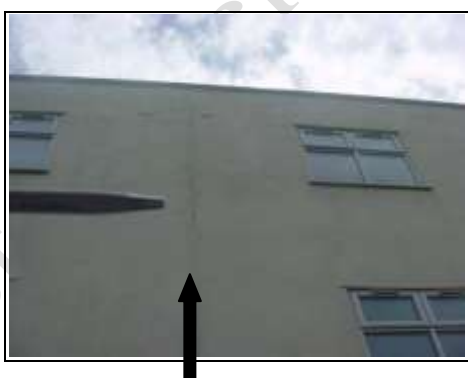
Vertical cracking

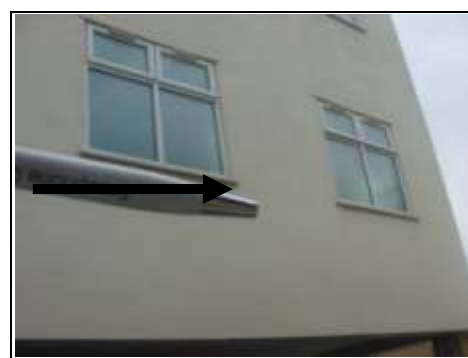
Horizontal cracking

We feel there is a combination of problems here. As you are aware there is dampness coming in from the roof. We also feel that now with the hairline cracks opened up over a fair amount of time there will be what is known as lateral dampness which is dampness coming through the structure.

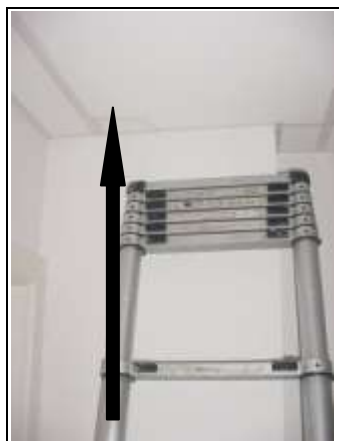
We will start by saying they are not as bad as the ones seen within XXXXX property. The dampness we can see, we believe, has come from the adjacent service duct which looks to be a soil and vent pipe (or possibly an internal downpipe as we haven't seen many downpipes to the roof). We suspect it to be a soil and vent pipe.

Staining to ceiling tile on the first floor

ACTION REQUIRED: The seal around the soil and vent pipe needs to be checked and also the plumbing pipes need to be checked for leaks. Alternatively, if this is an internal downpipe for rainwater then the decking on the roof will of course need to be lifted in this area and checked for leaks. We would add that there looks to have been some repainting and touching up carried out in the property. This could be where damp has come through, it could simply be where damage has occurred.

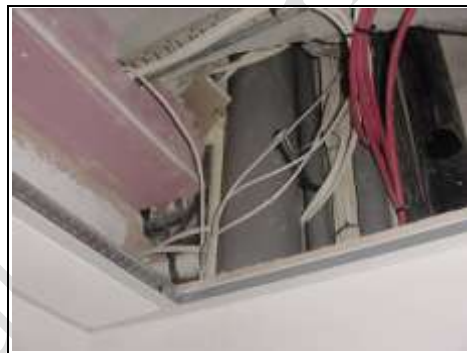
Dampness in the hallway on the first floor coming in through a tile which we lifted

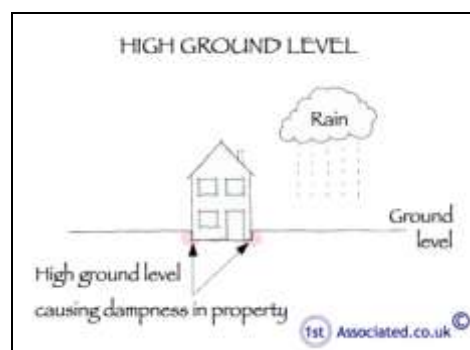
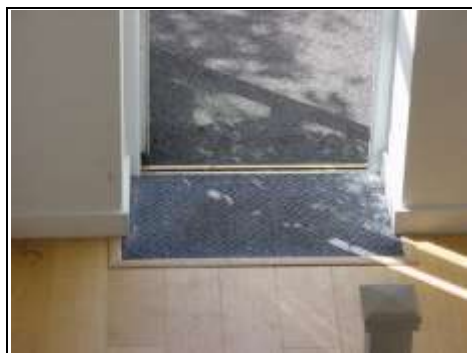
We noted there is little difference between the outside and the inside area, which does of course mean that you can get dampness in the property and could be prone to flooding.

Threshold to front of property is—
nearly same height as the outside
floor

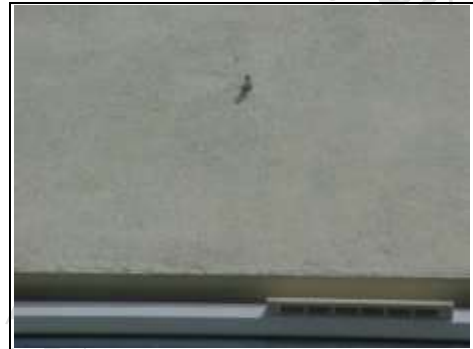
Firstly because we could not see it properly and secondly because the decking appears to go right up to the perimeter and therefore causing capillary action to the parapet wall.

Vent at high level where parapet wall is

Our recommendation is to remove the decking, check the roof and add a Pavia slab to protect the roof.

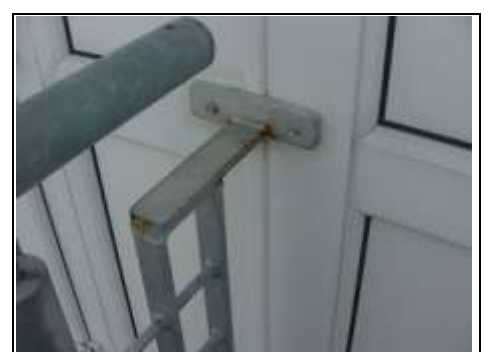
Our second concern is with regard to the parapet wall for a number of reasons, the coping stone which we have explained in more detail in the Executive Summary, the unusual weep hole details that we could see that we haven't come across previously in our many years of surveying and we could also see that the handrail is starting to rust.

Railings starting to rust

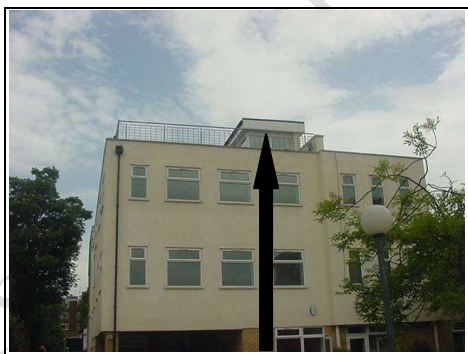
This is a felt flat roof. It is in slightly below average condition; we can see the cuts are uneven on the edge and the small upstand on this roof has not bonded correctly.

High level roof above stairs

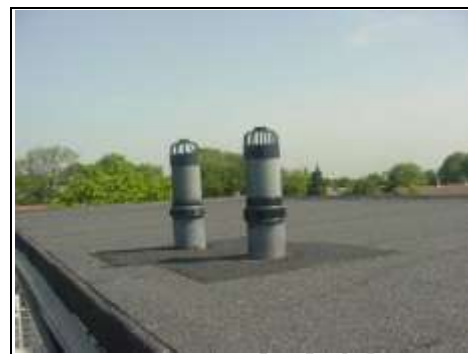
As mentioned, it looked like this is leaking.

Soil and vent pipes

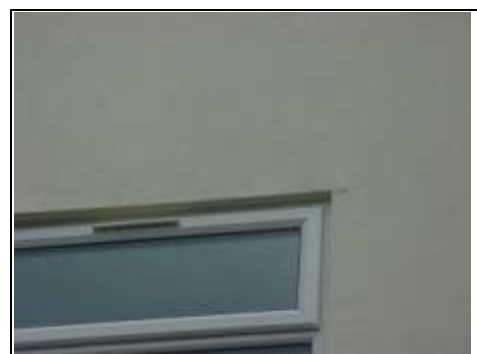
You can normally tell whether the render is good or not by the drip detail over the window and the bell mouth to the base of the property. There is a drip detail to all windows, although it is minimal in some cases.

Minimal drip detail

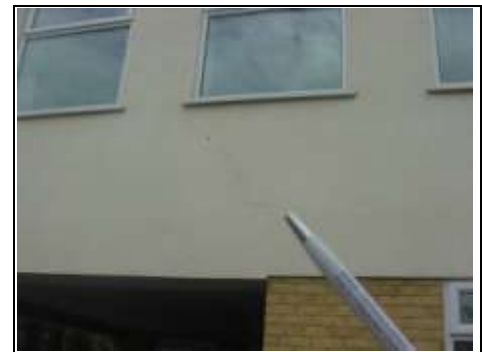
Hairline cracking throughout the render

We can see, as we are sure you can, hairline cracking throughout the render. This we believe comes from a combination of issues, including initial settlement and also dampness within the structure as a whole, and we believe too hard a cement based render, which allows for no movement in the structure.

Cracking to the front of the property

ACTION REQUIRED: Please see our comments in the Executive Summary.

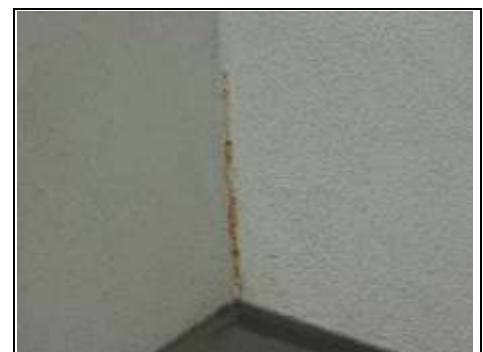
We can also see rusting to one of the angle beads, which means that an internal angle bead has been used externally as these rust.

Wrong angle beads have been used in some areas

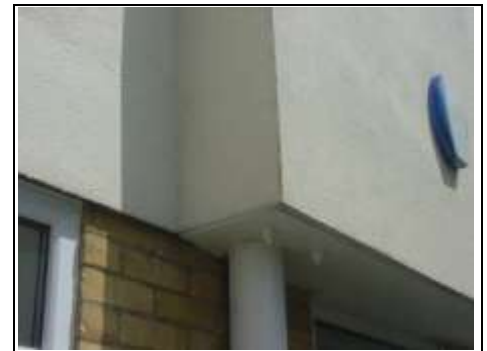
Close up of rusting column

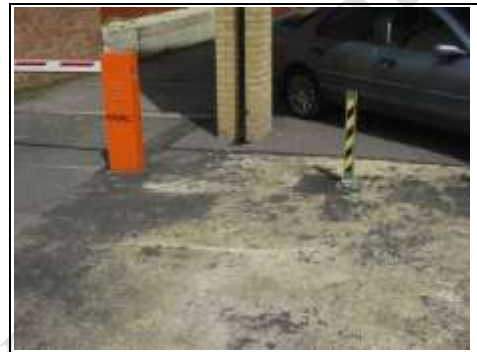
The new tarmac to the front of property concerns us. We feel it may relate to either the drainage alterations that the neighbour spoke about or to foundations that have been added or amended in this area.

New tarmac to front of property

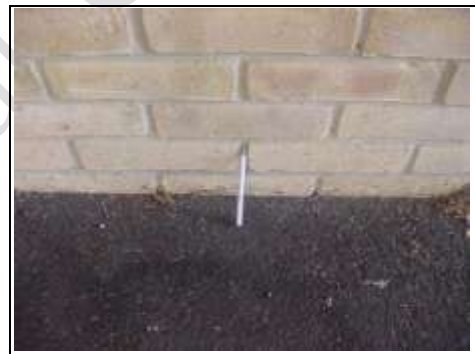
No DPC at all

ACTION REQUIRED: We recommend a French drain is added around the property / lowering of the ground level. We would add that we have never come across this in a modern property previously.

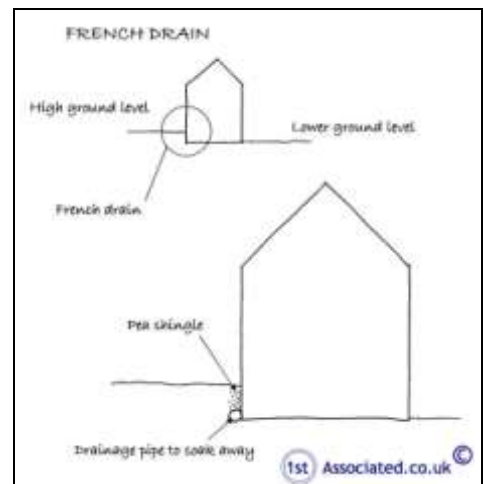
Grass growing along the edge

There is grass growing along the edge which indicates to us a problem with the DPC levels which is why we have recommended a French drain.

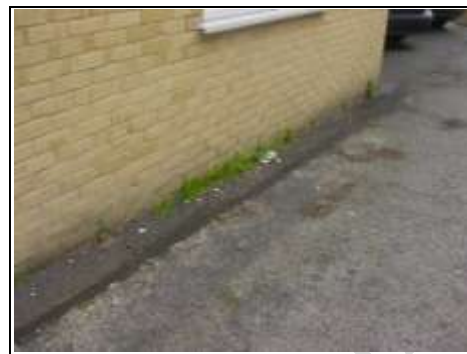
Grass growing around edge

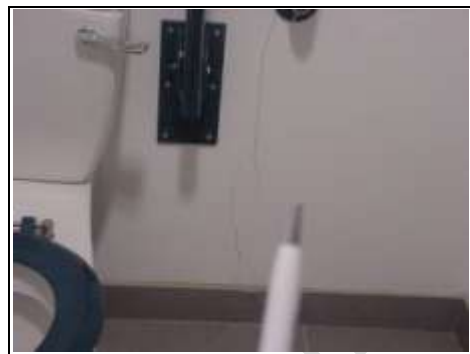
Vertical crack in disabled / less abled toilet

Vertical cracks are visible throughout the property. We rarely come across such pronounced cracks in a property of this age.

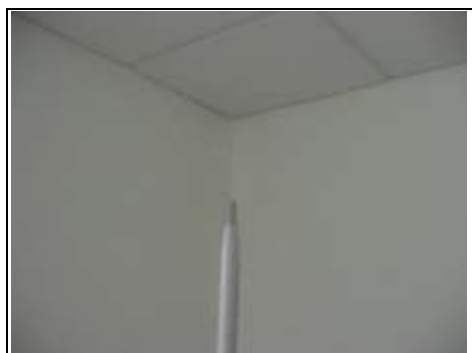
Pen indicating hairline cracks

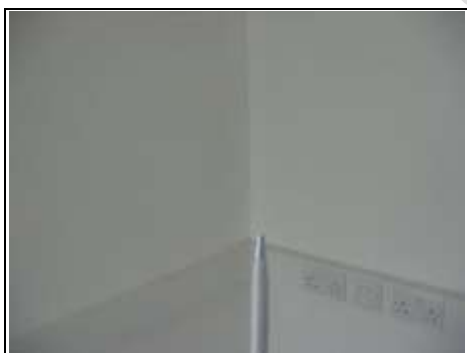
More hairline cracks

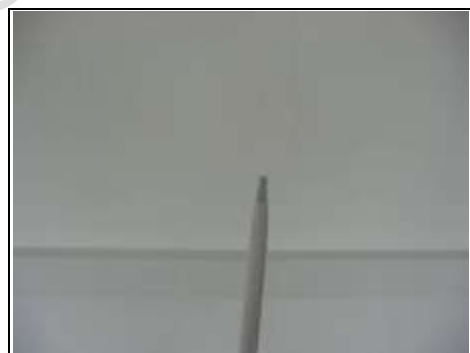
Further hairline cracks

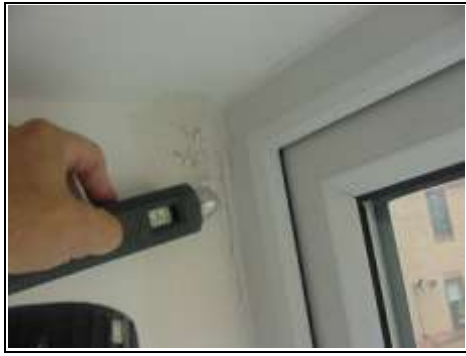
We used a damp meter on the external walls. We have found dampness.

High level dampness to window

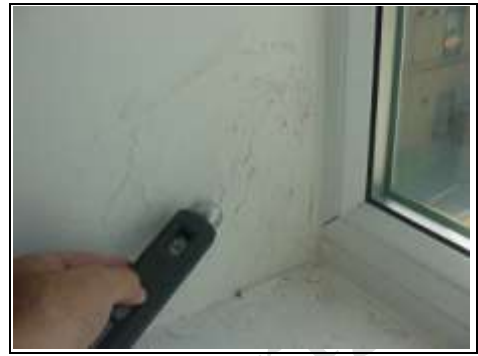
High level dampness

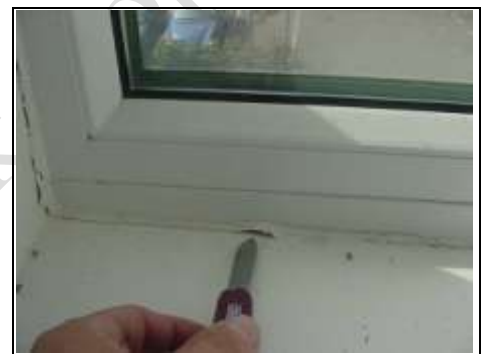
Mastic coming up on window
