# PROPERTY REPORT AND NEGOTIATION DOCUMENT

xxxxxxxxxx,  
xxxxxxxxxxxxxx,  
xxxxxxxxxx,  
Southampton,  
Hampshire,  
xxxxxxx

INDEPENDENT CHARTERED SURVEYORS

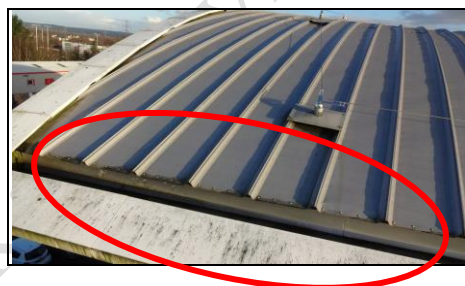
We can see that there is water damage and deterioration occurring underneath the domed roofs that are on both the left and the right of the property. We have not been on the roof but this usually relates to poor detailing and/or poor workmanship and/or poor materials. We feel that in this case it may be due to the box gutter detail allowing water into the property. Also, the edge of the roofing material looks to be delaminating.

Deterioration to end of sheets of domed roof on front left

**ACTION REQUIRED:** We recommend works in relation to the domed roof are excluded from the lease. We do not see any easy way of removing your liability other than excluding these areas from the lease.

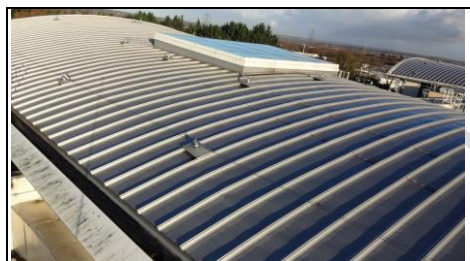
General view of dome on left side with old atrium. Atrium covering is very flat, we would expect water to impregnate in this area over the course of the lease

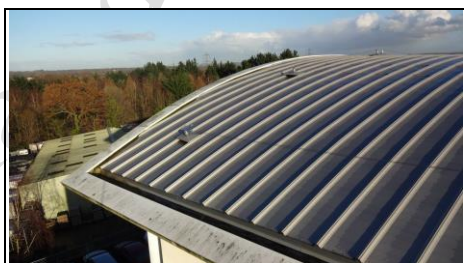
Discoloring to corner indicating water damage

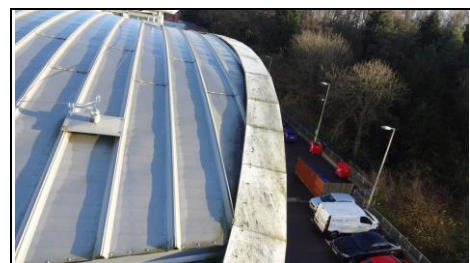
Ends of roofing panels coming away

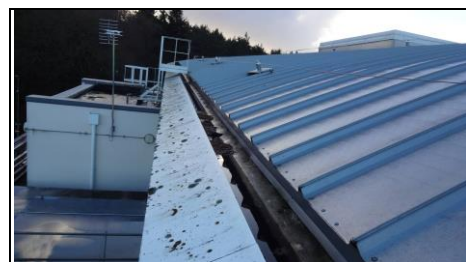
The domed roofs discharge into box gutters that run along the perimeter of either side of the property. These can be problematic and dampness looks to be getting into the building via these as well.

Debris and water sitting in box gutter on domed roof

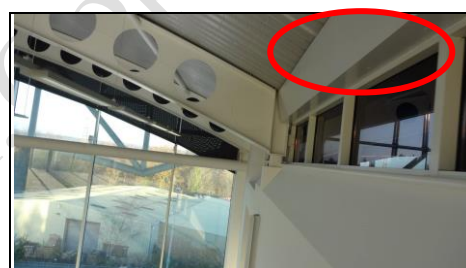
It looks like there has been high level repair work carried out so this is a known about problem.

Dots in corner where roof has been replaced at high level

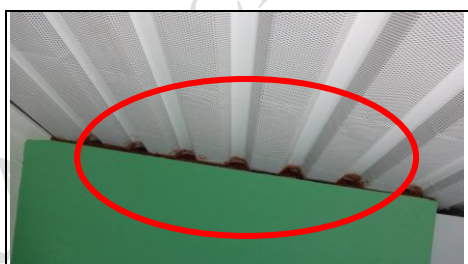
To several areas of the dome we can see repair work for example to the corners expanding foam has been used. Our concern is this may have been with regard to repairs of the roof or leaks in the area.

Expanded foam

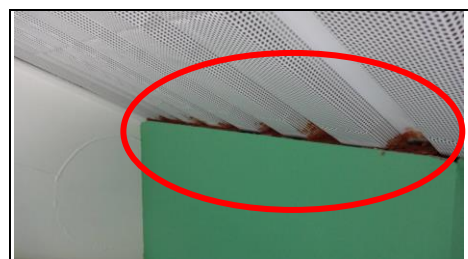
Marks where roof meets wall looks to be expanded foam

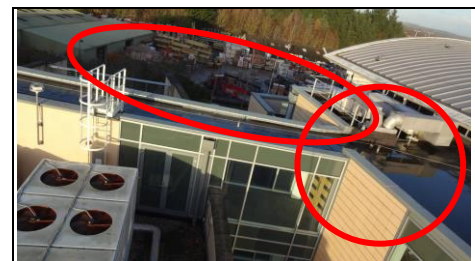
Leak to narrow roof over corridor  
Also ponding to flat roof

We would recommend removal of the entirety of the mono-ply roof, re-laid to falls, insulation added as appropriate to create the fall and a three layer felt system using a high performance elastomeric felt to replace it.

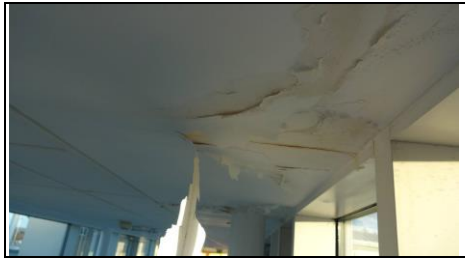
Leaks in corridor under flat roof

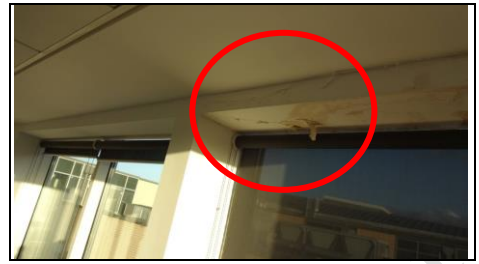
Leaks coming into property from flat roof

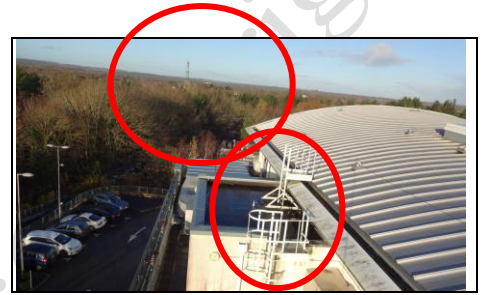
There are no obvious walkways adjacent to access the roof areas, etc so in addition foot traffic will tend to damage the single-ply system when any roofs are accessed.

Ladder access with no protected walkway

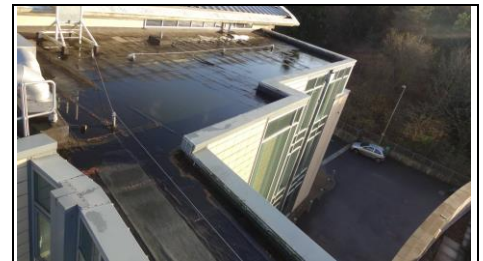
There looked to have been an attempt at some sort of protection of the mono-ply next to the man safe cable system in some areas and of course note the ponding.

This would be extremely difficult work due to the air conditioning units. Also, from what we can see a man safe system will need to be added. Attention should also be given to the flashings and detailing to ensure they are watertight. We recommend this is excluded from the lease.

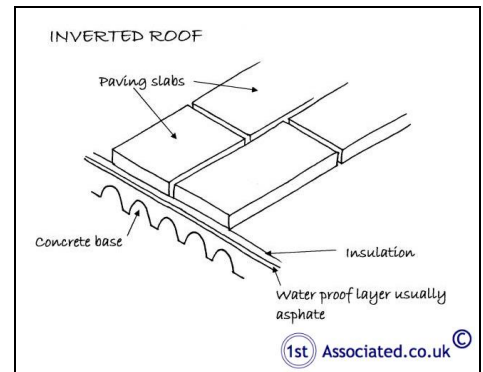
The balcony areas use an inverted roof system as far as we can see. An inverted roof is where the pavers cover the actual roof and there is normally a pea shingle or pebble infill to perimeters which allows access to the roofs. On a sunny day these areas can be quite pleasant, on rainy days they can allow water to sit on them and vegetation grow and ultimately this water then gets into the roof structure. We can see areas where vegetation is growing and sooner or later this will get into the building.

Inverted roof

**ACTION REQUIRED:** We would recommend that the inverted roofs are excluded from the lease as well as again water could already be in the structure; you have no way of knowing without opening up the structure.

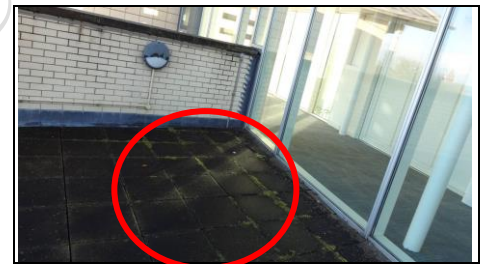
Vegetation growing on inverted roof

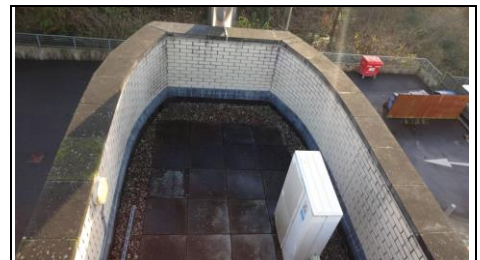
The inverted roof to the rear centre is an unusual inverted roof as it is almost inaccessible due to the air conditioning.

Inverted roof rear centre

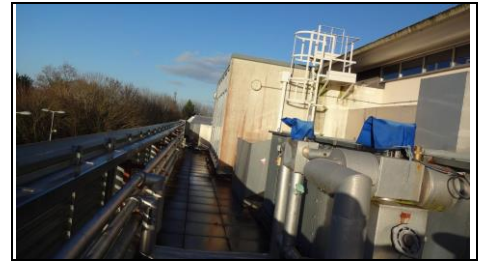
Inverted walkway used as walkway

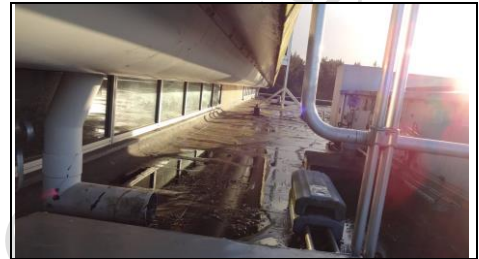
Another factor that we feel is adding to the problems with water getting into the property is the rainwater disposal. We have only had a limited inspection as we have not been able to go onto the actual roofs themselves however we can see for example to the front left hand side where a large hopperhead overflows directly onto a flat roof; we can see no obvious way of the water discharging quickly bearing in mind this downpipe is taking water from the large domed roof on the left side.

Rainwater from left domed roof discharging onto flat roof with nowhere to go as far as we could see

**ACTION REQUIRED:** Review all the rainwater goods.

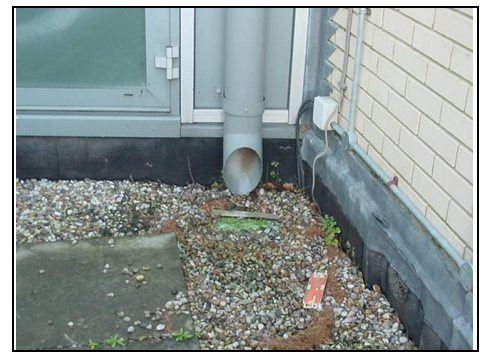
Rainwater pipe discharging onto inverted roof with no obvious flow path

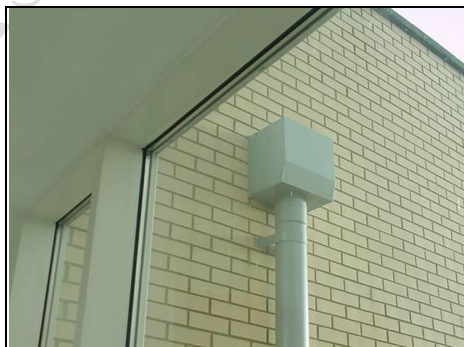
Dampness from leaking/overflowing hopperhead

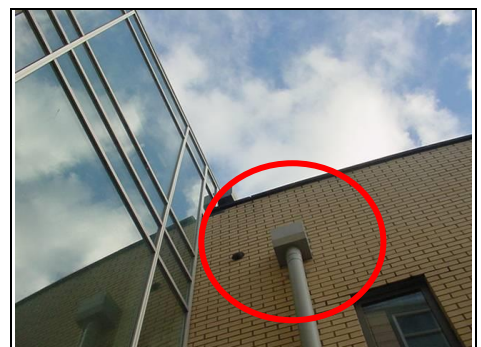
Some of the hopperheads seem to not be able to cope with the rainwater and this is leaking into the building. This can be seen generally throughout the building for example in the restaurant area and the link corridor area.

Hopperheads not able to cope with rainwater

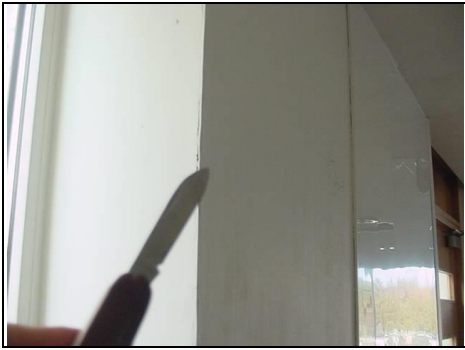
Dampness in restaurant

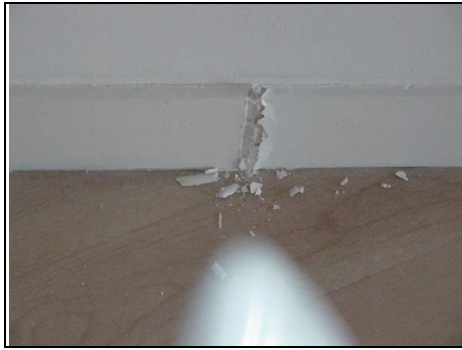
Dampness in skirting of restaurant

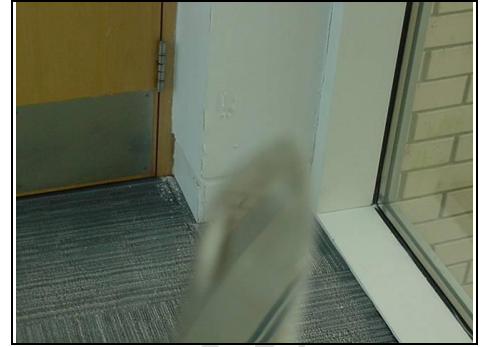
Dampness in first floor corridor from leaking hopperhead

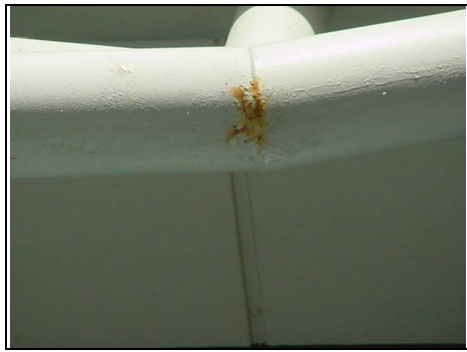
For example in this case under each of the canopies to the left and right roofs there is a tubular metal frame which is rusting.

Rusting to tubular steel

**ACTION REQUIRED:** Generally we need to open up the structure to comment further but specifically with regards to the tubular metalwork and indeed any metalwork that is rusting it needs work as soon as possible to stop the rusting as these are structural members and then it needs regular redecoration. Obviously if you can see rust as you can at the moment it is past its decoration date.

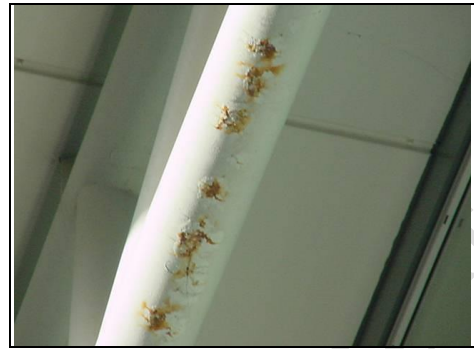
Rusting to tubular metal frame

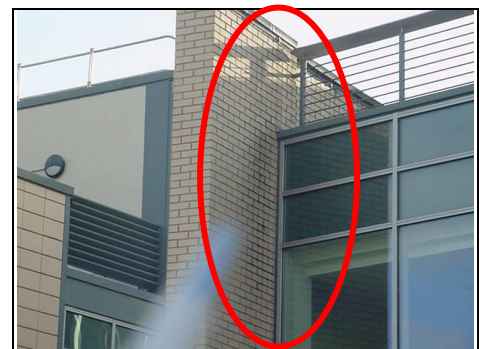
Moss to brickwork and pattern staining to front

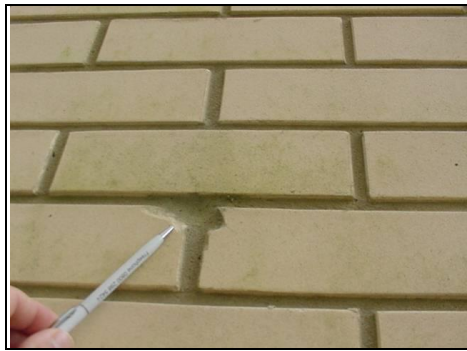
The walls have a stretcher bond brickwork pattern in quite a light brick. We can see the brick is being damaged from impact damage, etc during the course of the building work. We can also see that it is starting to get moss/lichen impregnated.

Damage to brickwork

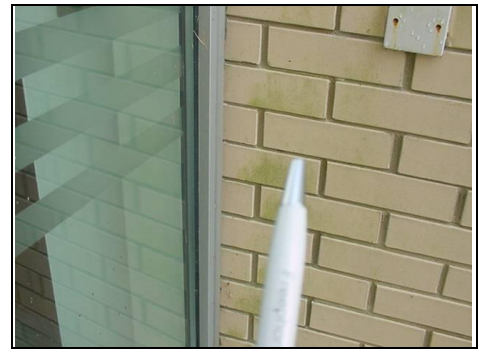
Moss impregnated into brickwork

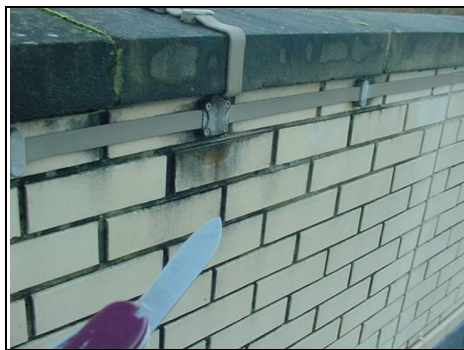
The top of the brickwork in some instances is protected with a coping stone. There are problems with this and it looks to be leaking at points or it could be that the drip details are incorrect.

Example of coping stones joints leaking

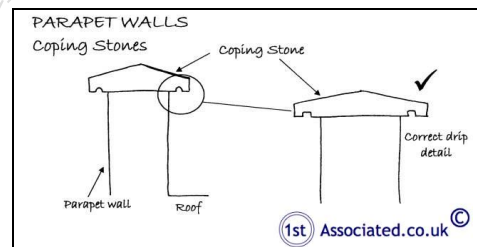
Drip details to coping stones

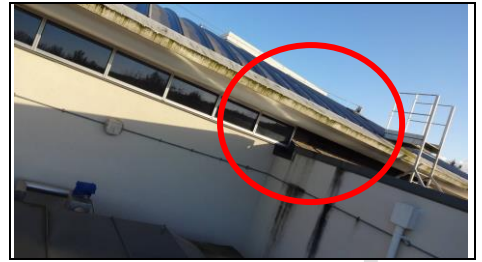
We could see the parapet wall was discharging onto the render. We have not opened up these areas however modern render tends to be cement based, fairly brittle and also relatively thin compared with renders of the past and damage and deterioration with cracking or any water getting into them can cause failure.

Parapet wall discharging onto render

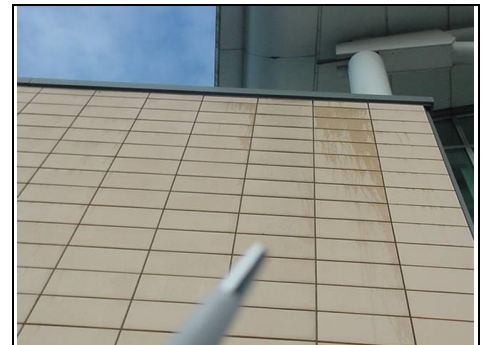
Rainwater going down rain cladding from coping above

**ACTION REQUIRED:** The areas will need cleaning or else they will look unsightly particularly where there are parapet wall details above which is discharging onto the brickwork and glazed curtain walling beneath.

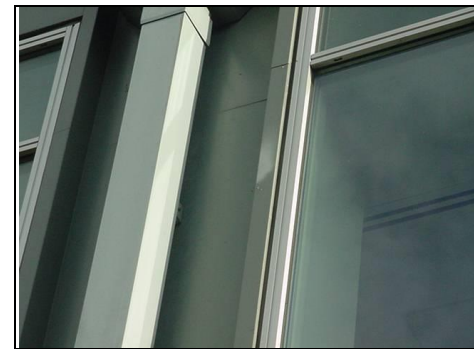
There are profile metal sheets at high level and also a vent type system. In the case of the main profile metal sheets they are starting to degrade, we could see some joints starting to open up and there is general weathering to the metal. We were not sure whether this metalwork has been sprayed before or cleaned; certainly something has happened to it. This is noticeable in particular behind where the downpipes are, the weathering of the profile metal sheeting.

Weathering to metal or it has been resprayed and missed an area

**ACTION REQUIRED:** This may be related to the box gutter leaking and the downpipes leaking or it may have been that it has been sprayed and it is a difficult area to spray. Either way we think the gauge thickness of the paint is very thin and that redecoration will be needed during the course of your lease and that it will be very difficult. We recommend this is excluded from the lease.

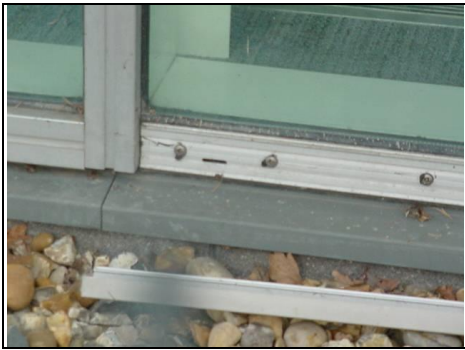
The glazed curtain walling is in a below average condition. We could see some of the transoms and mullions had become displaced as well as moss on the sills and them generally requiring cleaning.

Displaced

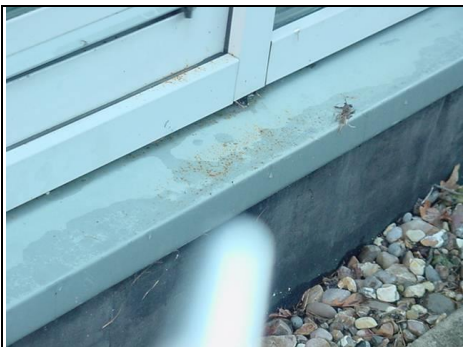
Rust to sill

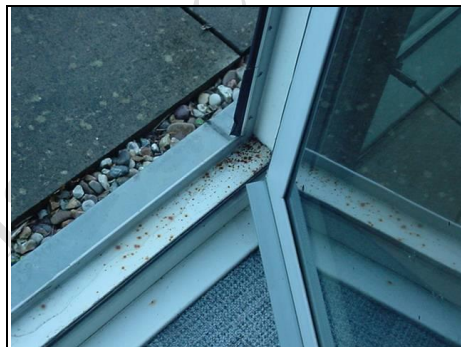
Rust spots to door

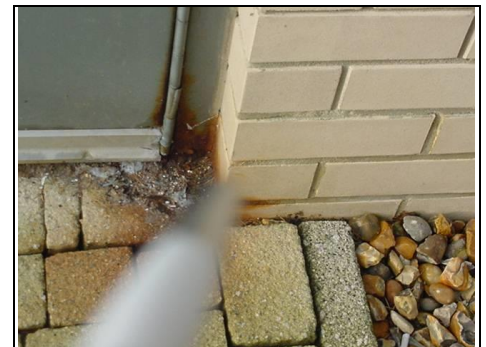
Rusting

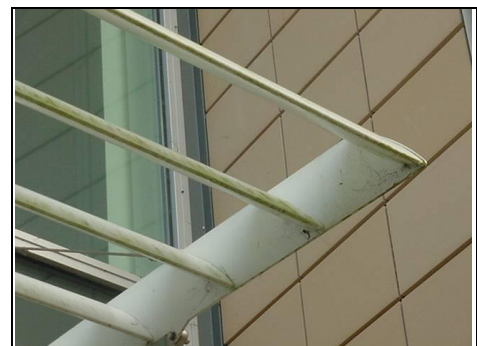
There are sunshades to many of the windows which have moss on them.

Sunshade

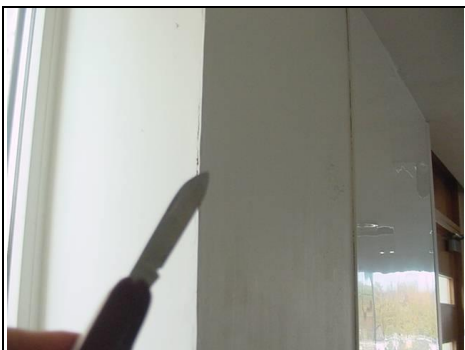
Unfortunately we feel this is a design fault with the hopperheads, possibly the roofing as well and the copings. We believe the hopperheads are allowing water to discharge down the building and this is then soaking in through the wall structure.

Dampness in restaurant

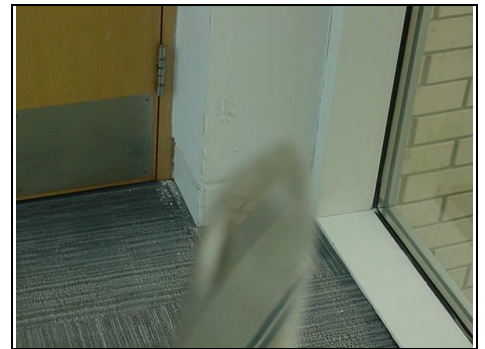
Dampness in first floor corridor from leaking hopperhead

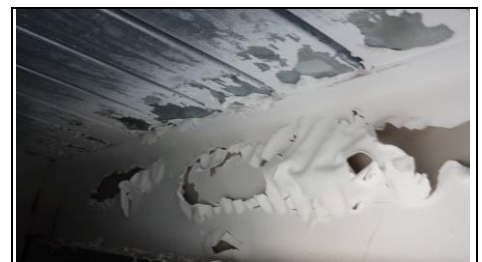
We believe this relates to flat roof failure. Please see our comments with regard to problems with the roofs and the difficulty in resolving the problems. We feel the roofs should be excluded from the Full Repairing and Insuring lease and any associated damage. We noted in particular to the left hand second floor office that the water damage was so bad it had affected most of the room. It was causing the fire protective paint to perish. Our concern is

Paint perishing on top floor

that there may be areas where the fire protection has been damaged and this has not been seen and there may be other areas where other damage is occurring unseen.

**ACTION REQUIRED:** We would recommend that every room ceiling is inspected, lifting the ceiling tiles or thermal imaging the area to establish any problems.

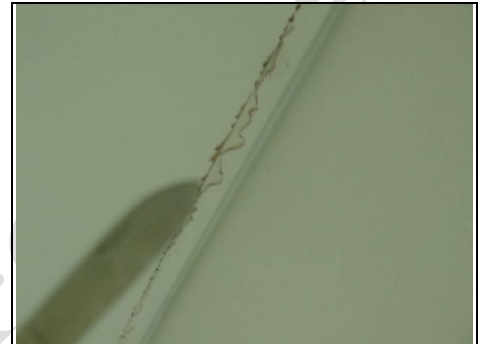
With so much water getting into this building there is some movement visible internally, for example we can see to the right hand corner movement visible internally. Our concern is that continued water ingress into this property will cause structural damage to it. There are already elements visible such as the tubular steels to the domed roof that are rusting. This leads us to believe there has been a lack of general maintenance on the property and effectively it will be soaking the water up like a sponge which is never good for a building.

Cracking to ceiling ground floor front right

**ACTION REQUIRED:** We would exclude all of the roofs and any cracks that become visible in this property we feel should be carried out as part of either landlords works or as an insurance claim by the landlord. We feel that the landlord should, as part of your lease agreement, place an insurance claim with his insurers and/or take appropriate legal action with the companies involved in this building.

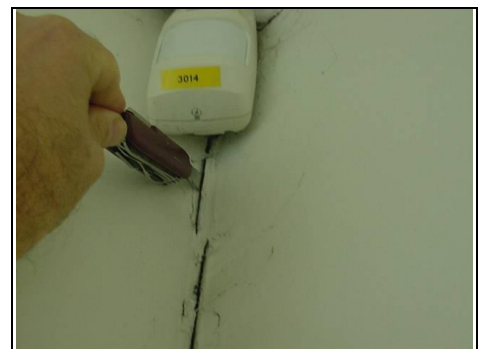
Cracking to wall ground floor front right

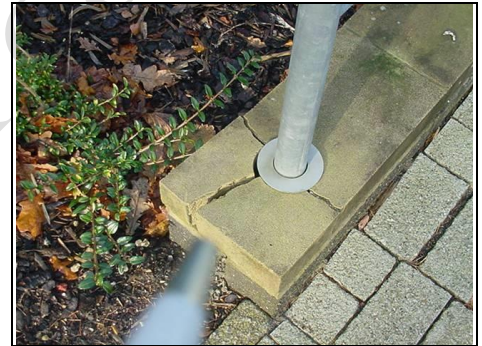
Damage to ramp access

**ACTION REQUIRED:** You need to ensure that the external areas are also excluded appropriately from the lease.

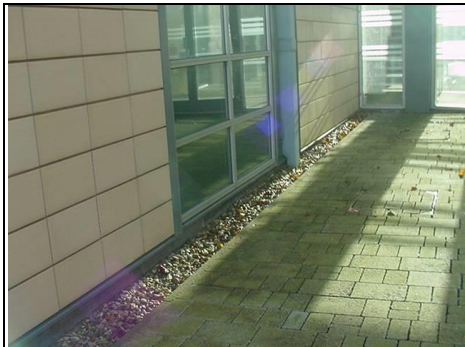
Moss to paved area at front

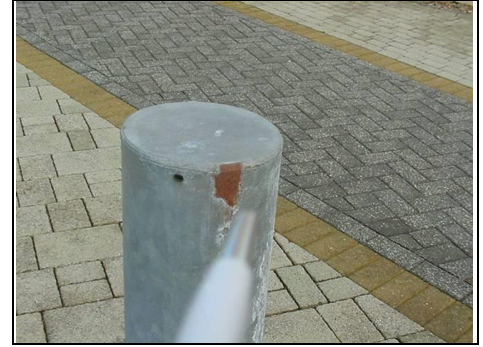
Bollard rusting

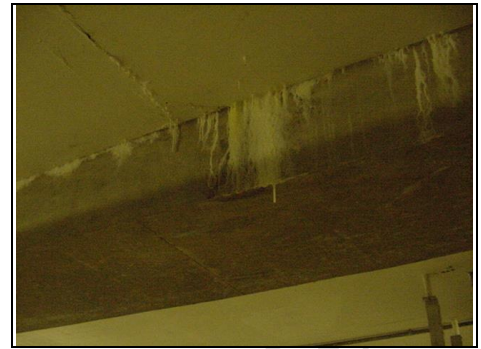
There looks to be long term leaks within the car park as we can see stalactites and also can see there are areas of staining, etc to the ceiling of the underground car park which leads us to believe there have been long term problems with leaks.

Stalactites

**ACTION REQUIRED:** Exclude any leak damage from the lease.

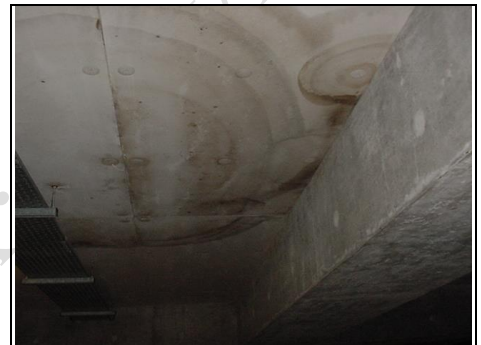
Staining to concrete
