SCHEDULE OF CONDITION

We have been instructed to inspect and prepare a Schedule of Condition for xxxxxxxxxxxx, W14 xxx. We inspected the property on 23rd May 2013.

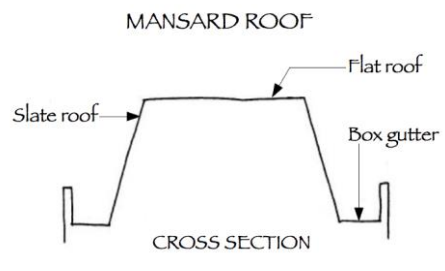
<p>Dormer windows:</p> <p>Clad in lead</p>	<p>Flat roof not visible</p> <p>Leaks were visible on the top floor</p>

<p>Make watertight.</p> <p>Make watertight</p>

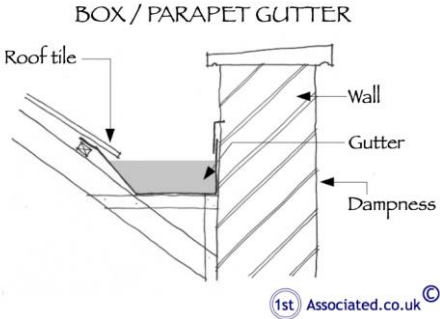
<p>Parapet wall:</p> <p>Brick (hidden box gutter)</p>

<p>Box gutters are renowned for leaking.</p>

<p>Ensure watertight.</p>
<p>Walls:</p> <p>Flemish bond brickwork with tuck pointing</p>

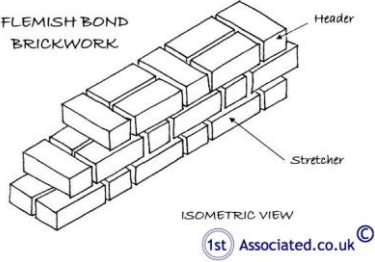
<p>Opening of brickwork noted.</p>

<p>Ad hoc re-pointing.</p>

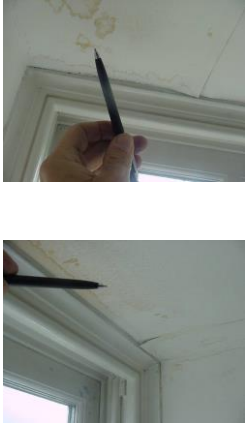
<p>Dormer windows:</p> <p>Clad in lead</p>

<p>Staining visible around the dormer windows on the top floor.</p>	<p>Make watertight</p>
<p>Rear Box Gutter</p>

<p>Wire mesh to stop debris getting in</p>	<p>Secure slate.</p> <p>Assume this is a known about problem, which is why the metal grill has been placed in the box gutter. Obviously slates into the box gutter can also damage the box gutter.</p>

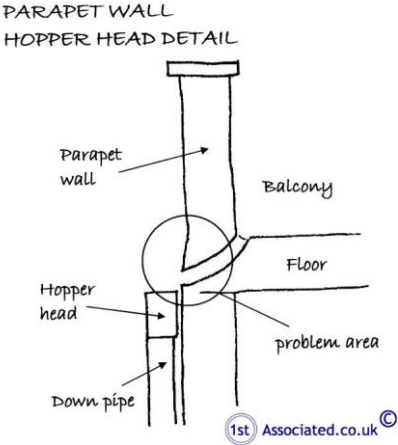
<p>Pigeon Deterrent</p>

<p>Pigeon deterrent on hopperhead and to roof</p></div>	<div><p>We viewed the gutters from ground level.</p><p>Dated.</p>

</div>	<div><p>Ensure all downpipes are watertight.</p><p>Repair downpipes and secure as necessary, ensure downpipes are clean and clear.</p></div>
--	--	--

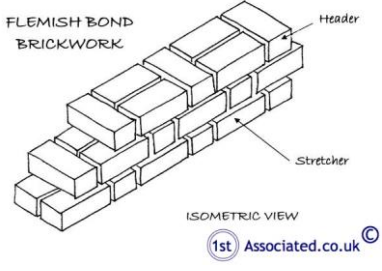
<p>Mastic joint allows expansion of brickwork</p>

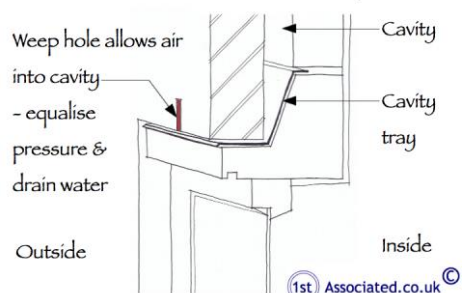
<p>WEEP HOLES ABOVE WINDOWS/DOORS</p>

<p>Weep holes</p> <p>We believe the walls are a cavity construction due the weep holes.</p>	<p>Average</p>

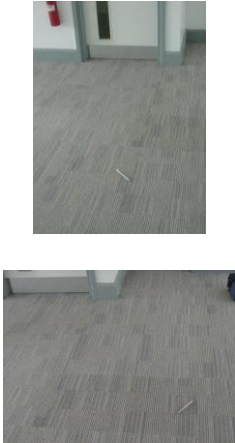
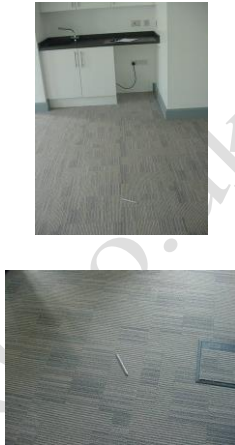
Various areas of rocking particularly around entrance door and towards the front area and left side

The rocking comes from areas of heavy use. In our experience it is very difficult stop the rocking without lifting the entire floor and re-laying.

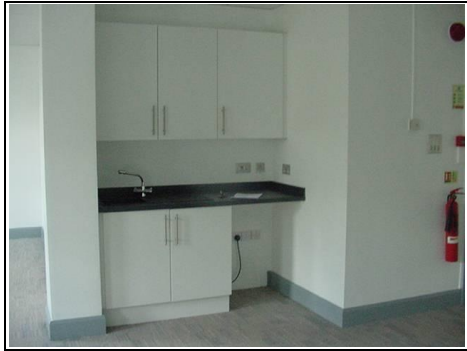
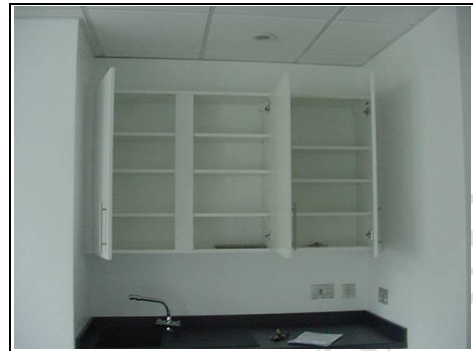
Kitchenette

DESCRIPTION	CONDITION	ACTION REQUIRED
Ceilings: Suspended ceiling system with exposed grid	Staining	Resolve leak and replace ceiling tiles.
Walls: Painted	Dated	
Floors: Carpet on suspended metal	Dated	Clean or replace
Detailing: Units: Wall mounted Floor mounted	Average

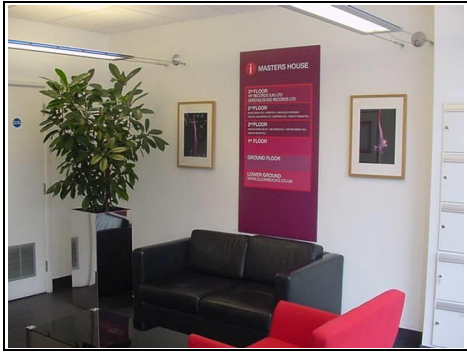
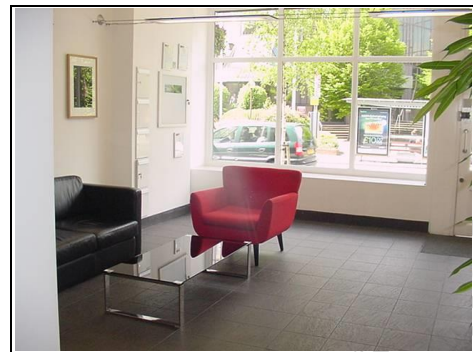
Reception Area

Damp to ceiling tiles

Resolve dampness. Repair, prepare and redecorate.
Walls: Painted	Dampness coming in via service duct. Dated

Resolve dampness, repair, prepare and redecorate
Floors: Tiled	Average

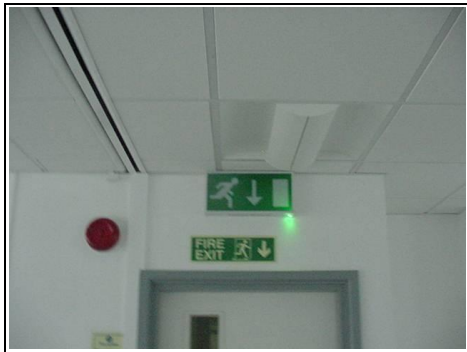
Fire exit signs are correct

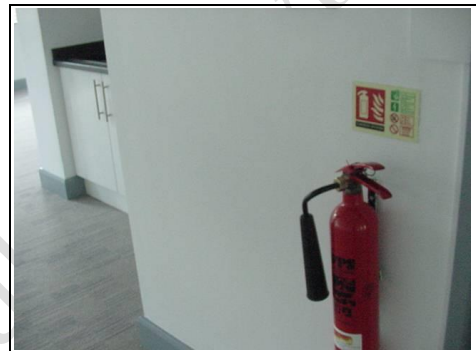
Fire extinguisher has a sign noting what it should be used for

ACTION REQUIRED: You need to check and confirm with the office managers that there is a contract in place with regard to fire safety.
