## SCHEDULE OF CONDITION

INDEPENDENT CHARTERED SURVEYORS

We have been instructed to inspect and prepare a Schedule of Condition for  
xx.  
We inspected the property on xxxxxxxxxxxx.

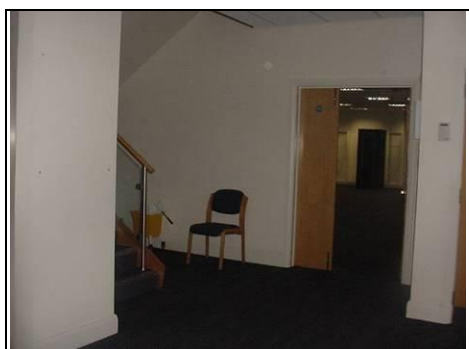
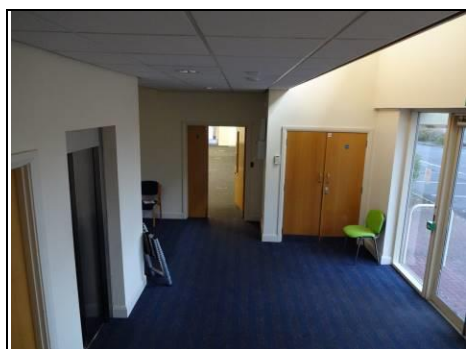
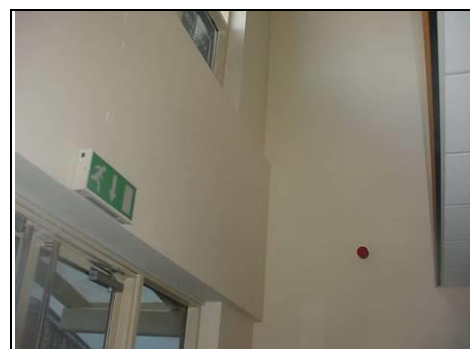
DESCRIPTION	CONDITION	ACTION REQUIRED
<b>Ceilings:</b>  <b>High ceiling:</b>  <b>Low ceiling:</b> Suspended ceiling tiles with exposed grid	Dated and marked	Assumed does not form part of the Lease agreement  Ad hoc replacement likely to require the whole of the ceiling to be replaced to match.
<b>Walls:</b>		
Painted	Dated and marked, particularly around entrance door areas

Repair, prepare and redecorate

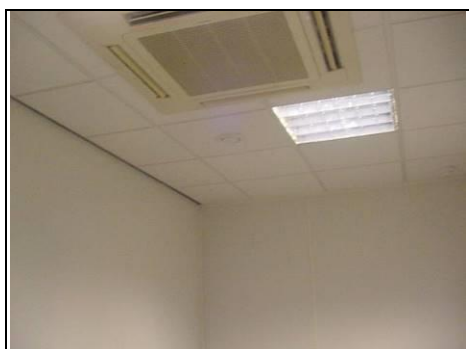
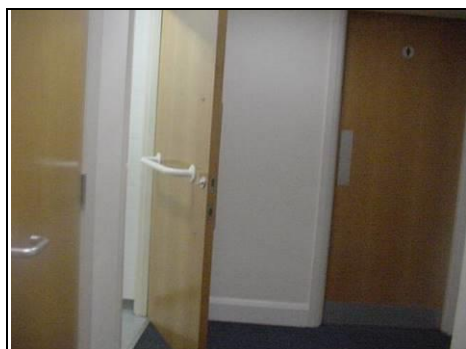
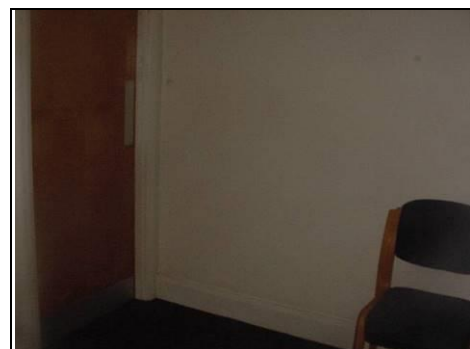
DESCRIPTION	CONDITION	ACTION REQUIRED
<b>Ceilings:</b>  Suspended ceiling tiles with exposed grid	Tile missing	Clean ceiling grid and replace new ceiling tiles.
<b>Walls:</b>  Painted  Timber skirting	Hairline cracking and marks	Repair, prepare and redecorate
<b>Floors:</b>  Carpet tiles	Dated	Clean or replace
<b>Detailing:</b>  <b>Doors:</b>  Veneer doors	Dated	Clean. Repair, prepare and redecorate
<b>Services:</b>  Lighting		See Services Section  Clean

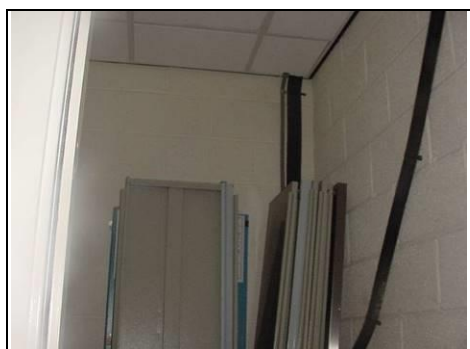
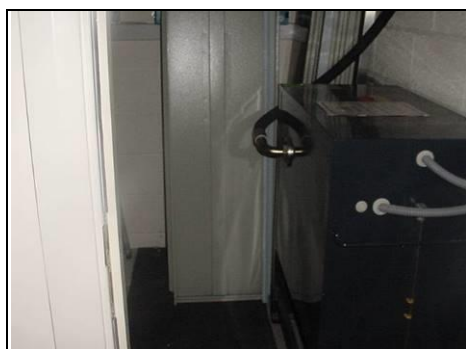
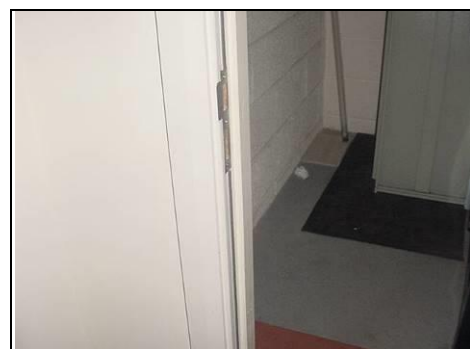
DESCRIPTION	CONDITION	ACTION REQUIRED
<b>Ceilings:</b>  Suspended ceiling tiles	One tile has been moved	Replace missing ceiling tile and match
<b>Walls:</b>  Painted blockwork	Dated	Repair, prepare and redecorate
<b>Floors:</b>  Vinyl safety floor  Painted upstand	Dated   General stored items	Clean or replace   Landlord to remove stored items.
<b>Detailing:</b>  <b>Door:</b>  Veneer door Note: door does not have a door closer	Knots grinning through door frame	Clean. Repair, prepare and redecorate
<b>Services:</b>  Lighting		See Services Section

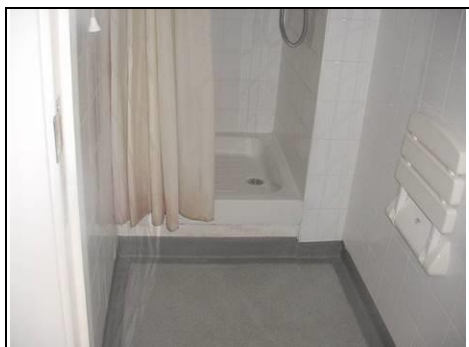
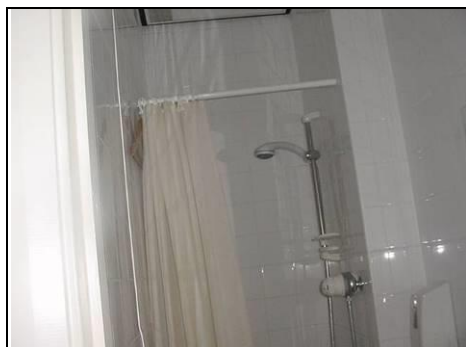
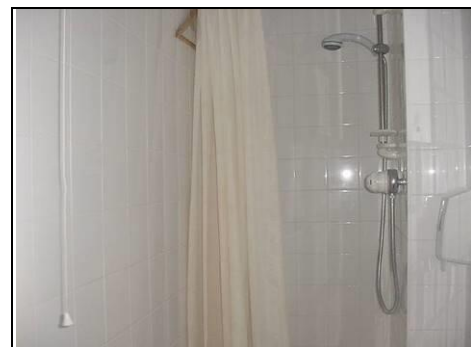
Shower cubicle

DESCRIPTION	CONDITION	ACTION REQUIRED
<b>Ceilings:</b>  Suspended ceiling tiles with exposed grid	Dated Different colour ceiling tiles

Clean ceiling grid and replace with new ceiling tiles.
<b>Walls:</b>  Tiled from floor to ceiling	Dated	Repair, prepare and redecorate
<b>Floors:</b>  Vinyl safety floor	Dated Discolouration under shower

Clean or replace

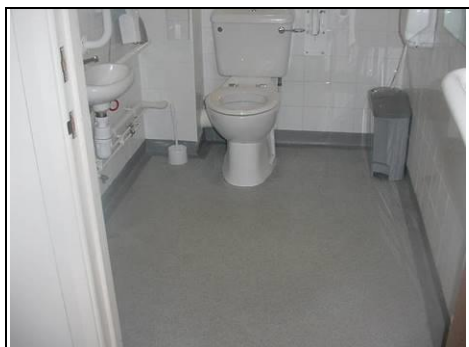
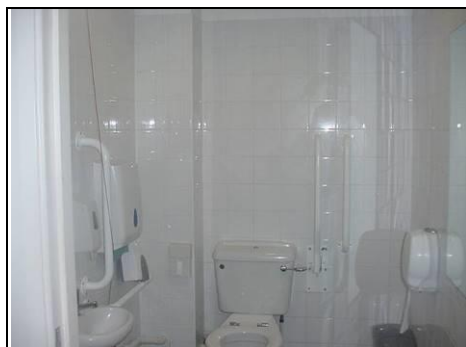
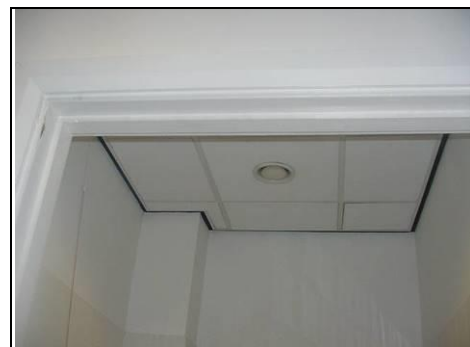
DESCRIPTION	CONDITION	ACTION REQUIRED
<b>Ceiling:</b>  Suspended ceiling tiles with exposed grid	One damaged ceiling tile  	Clean ceiling grid and replace new ceiling tiles.
<b>Walls:</b>  Painted at high level  Tiles to approx. two metres in height	Dated and old fixing points  	Repair, prepare and redecorate
<b>Floors:</b>  Vinyl safety floor	Dated	Clean or replace

<b>Sanitary Ware:</b>  One WC  One wash hand basin	Dated  Dated	Deep clean  Deep clean
<b>Detailing:</b> <b>Doors:</b>  Veneer door	Damaged Knots grinning through door frame

Make good or replace.
<b>Services:</b>  Lighting  Emergency cord pull Assistance handles and bars		See Services Section

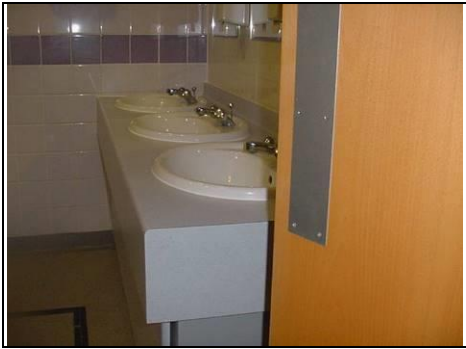
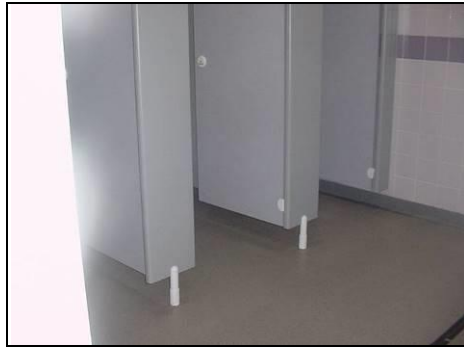
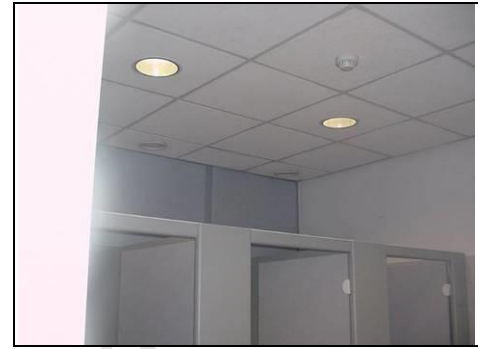
DESCRIPTION	CONDITION	ACTION REQUIRED
<b>Ceilings:</b>  Suspended ceiling tiles with exposed grid	Stained

Marks and visible dampness to right corner, affecting paintwork

<p>Cracked tile next to switch point, old stickers, marks and damaged tiles where meets plastic skirting</p>

One manhole cover – not inspected	 	
Plumbing – mixture of copper and plastic pipes	<p>Dampness caused by pipework problems.</p>  	Resolve dampness and make good.

Clean ceiling grid and replace new ceiling tiles.
<b>Walls:</b>  Painted at high level

Resolve dampness.  Repair, prepare and redecorate

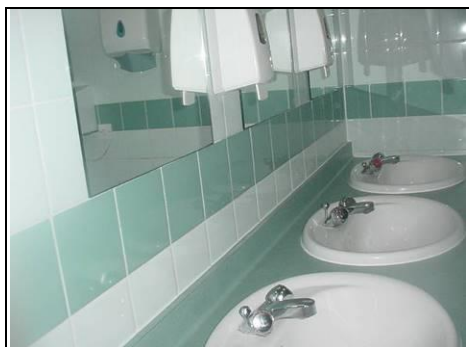
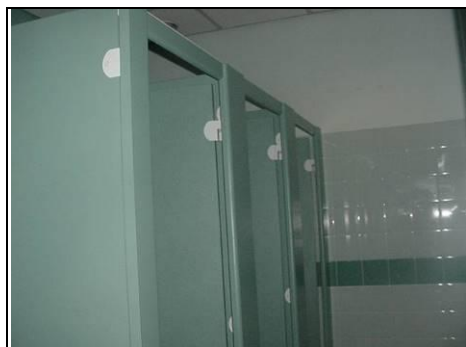
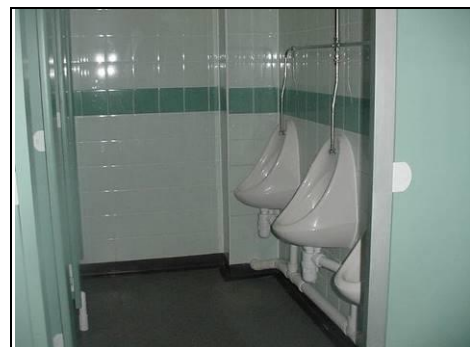
Dated, stained and damaged Poorly cut tiles to right edge near WC's

Old marks  Cracking at corner joints	Repair, prepare and redecorate  Make good cracking.

Clean ceiling grid and provide new ceiling tiles throughout.
<b>Walls:</b>  Painted at high level

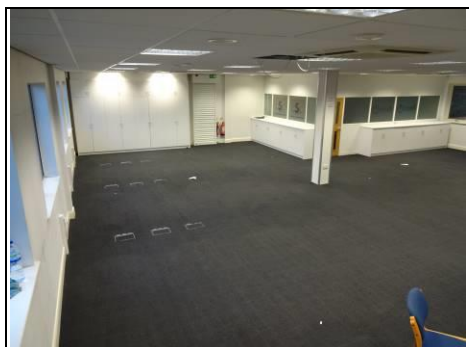
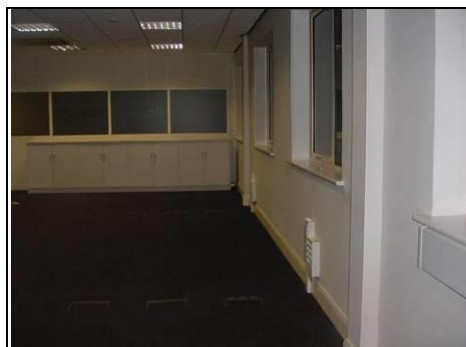
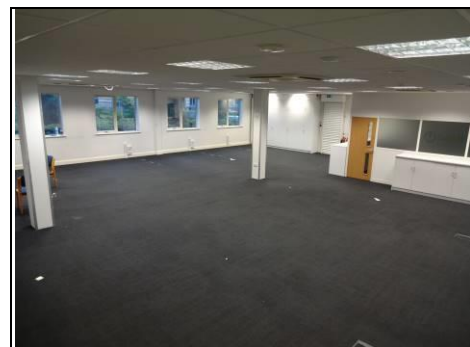
General marks and water staining

<p><b>Walls:</b></p> <p>Painted</p>   <p>Damage to front left</p> <p>Old fixing points</p>   <p>Two Columns: one has plumbing for water cooling</p>	<p>Used and abused</p>   <p>Damage to front left</p> <p>Dated and old fixing points</p> <p>Dated Hole on one column</p> <p>Dated and old fixing points</p>  	<p>Repair, prepare and redecorate</p> <p>Repair, prepare and redecorate</p> <p>Repair, prepare and redecorate</p>
<p><b>Floors:</b></p> <p>Carpet</p> <p><b>Cabinets/lockers:</b></p>	<p>Dated</p> <p>Dated Old fixing points</p>	<p>Clean or replace</p> <p>Repair, prepare and redecorate</p>

Resolve water/dampness problem.  Clean ceiling grid and replace with new ceiling tiles.

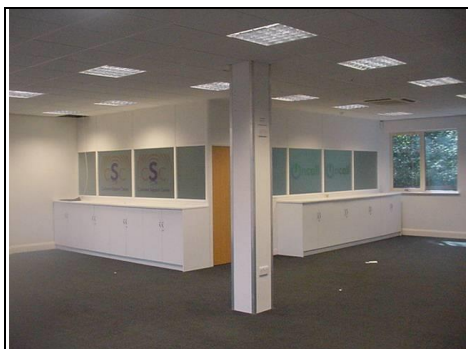
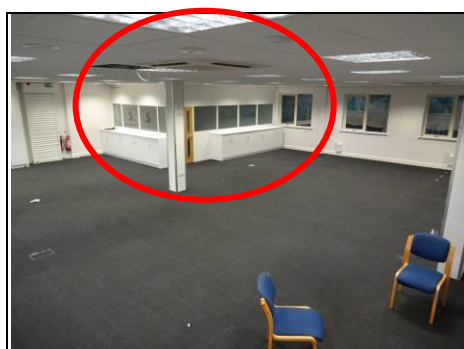
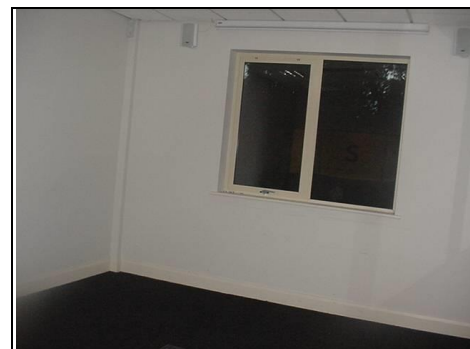
DESCRIPTION	CONDITION	ACTION REQUIRED
<b>Ceilings:</b>  Suspended ceiling tiles with exposed grid    Marks to ceiling tiles	Dated and marked   	Clean ceiling grid and replace new ceiling tiles.
<b>Walls:</b>  Painted    Marks to wall	Dated and marked    Old fixing points	Repair, prepare and redecorate

<p><b>Partitions:</b> with branded windows</p>   <p>Outside looking at partitions</p> <p>Mixture of timber and plastic skirtings</p>	<p>Dated</p>   <p>Inside looking at partitions</p> <p>Dated</p>	<p>Remove branding signs from windows.</p> <p>Clean. Repair, prepare and redecorate</p> <p>Repair, prepare and redecorate</p>
<p><b>Floors:</b></p> <p>Carpet</p>  	<p>Dated</p>	<p>Clean or replace</p>
<p><b>Detailing:</b></p> <p><b>Windows:</b></p> <p>One double sized window</p> <p><b>Doors:</b></p> <p>Veneer door with two vision panels</p>	<p>Dated</p> <p>Dated</p>  	<p>Clean, repair, prepare and redecorate</p> <p>Clean. Repair, prepare and redecorate</p>
<p><b>Services:</b></p> <p>Lighting</p>		<p>See Services Section</p>

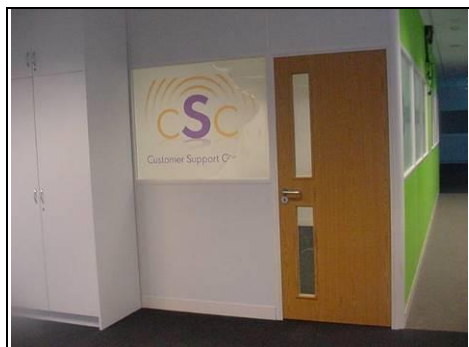
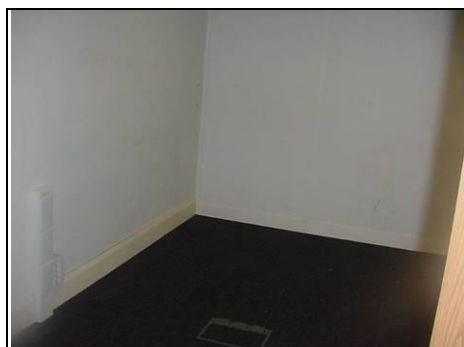
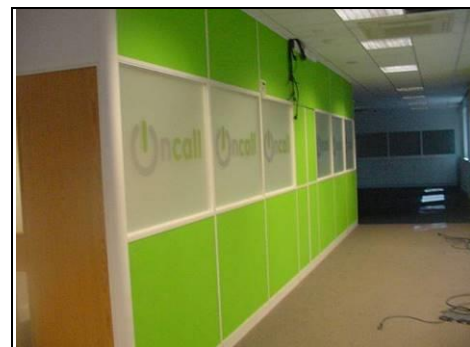
DESCRIPTION	CONDITION	ACTION REQUIRED
<b>Ceilings:</b>  Suspended ceiling tiles with exposed grid	Dated	Clean ceiling grid and replace new ceiling tiles.
<b>Walls:</b>  Painted       Partitions	Dated Old fixing points Coffee/tea stains

Repair, prepare and redecorate       Repair, prepare and redecorate
<b>Floors:</b>  Carpet	Dated	Clean or replace

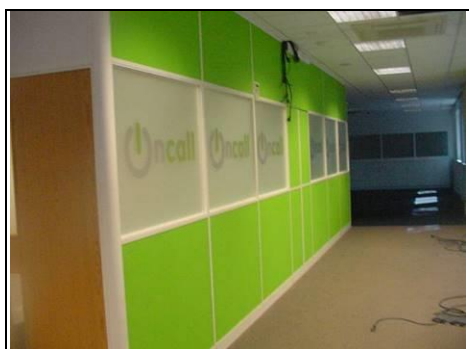
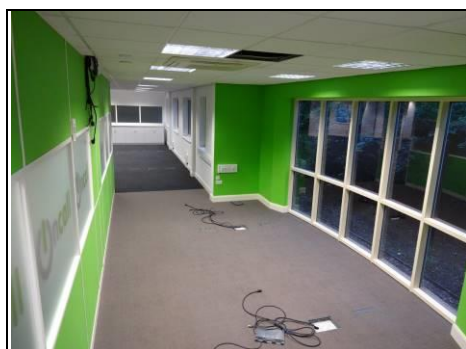
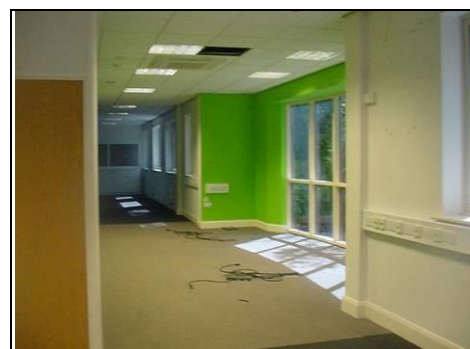
DESCRIPTION	CONDITION	ACTION REQUIRED
<b>Ceilings:</b>  Suspended ceiling tiles with exposed grid	Dated  	Clean ceiling grid and replace new ceiling tiles.
<b>Walls:</b>  Painted

Old fixing points and fixtures still on wall

Dated  Dated	  Repair, prepare and redecorate  Repair, prepare and redecorate
<b>Floors:</b>  Carpet	  Dated	  Clean or replace
<b>Detailing:</b>  <b>Windows:</b>  Five windows	  General deterioration to film on windows	  Clean/Repair, prepare and redecorate
<b>Services:</b>  Lighting  Loose cabling to the floor	  	See Services Section   Remove

Repair, prepare and redecorate

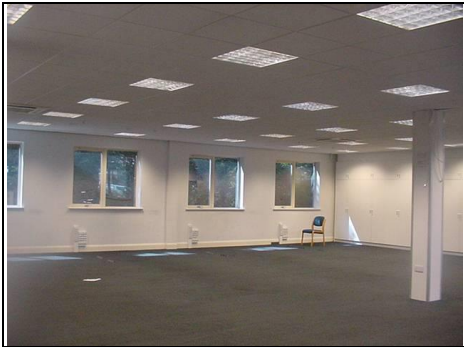
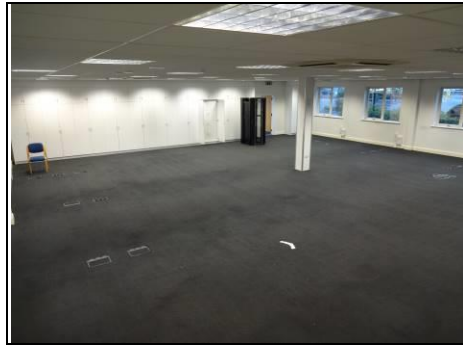
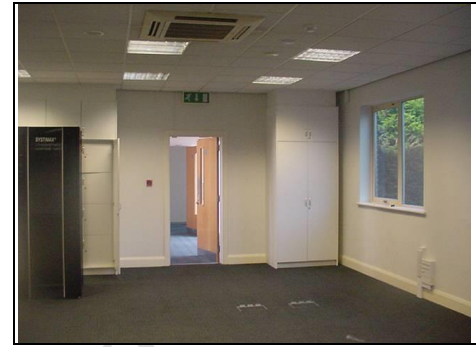
DESCRIPTION	CONDITION	ACTION REQUIRED
<b>Ceiling:</b>  Suspended ceiling tiles with exposed grid with flush mounted lighting and comfort cooling	Dated and marked	Clean ceiling grid and replace new ceiling tiles.
<b>Walls:</b>  Painted

Timber skirting	Dated, used and abused. Old fixing points

<p>Cabinets/lockers to left and right</p> <p>Two columns</p> <p>Work lockers</p>   <p>Old computer server</p>	<p>Dated</p> <p>Old fixing points</p>  	<p>Repair, prepare and redecorate</p> <p>Previous tenant's computer server remove</p>
<p><b>Floors:</b></p> <p>Carpet</p>	<p>Dated</p>	<p>Clean or replace</p>
<p><b>Detailing:</b></p> <p><b>Windows:</b></p> <p>Five Front windows four double sized and one single</p> <p>Five Rear windows four double sized and one single</p>   <p>Broken keep</p>  	  <p>General deterioration to film on windows</p>   <p>One right window with old sticker</p>   <p>Rear middle window with crinkling of film.</p>	<p>Clean, repair, prepare and redecorate</p>

<b>Window Ironmongery:</b>	Some missing	Replace missing window ironmongery
<b>Doors:</b>  Veneer door with vision panel	Dated	Clean/Repair, prepare and redecorate
<b>Services:</b>  Flush mounted lighting  Comfort cooling		See Services Section.

Dated	Repair, prepare and redecorate.   Repair, prepare and redecorate   Repair, prepare and redecorate
