# SCHEDULE OF CONDITION/ EXAMPLE DILAPIDATIONS REPORT

xxxxxxxxxxxxxx,  
xxxxxxxxxxxxxxxxxx,  
xxxxxxxxxxxxxxxxxx,  
xxxxxxxxxxxxxxxxxx,  
Surrey, xxxxxxxx

We have prepared a Schedule of Condition for xxxxxxxxxxx xxxxxxxxxxx xxx xxxxxx  
xxxxxxxxxxxxxxxx xxxxxxxxxxx. This Schedule of Condition is along the lines of a  
Dilapidations Report to show you the sort of things that will typically be identified in  
a Dilapidations Report. We have provided a Property Report to give you advice on  
how we would recommend you deal with these.

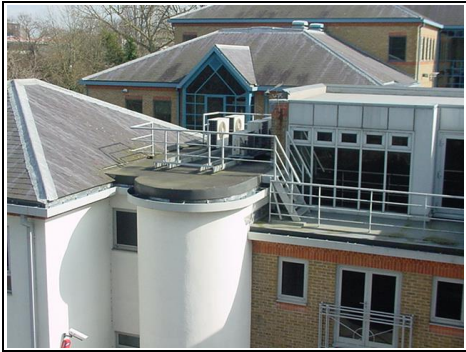
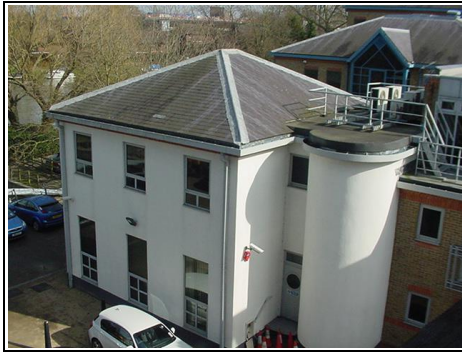
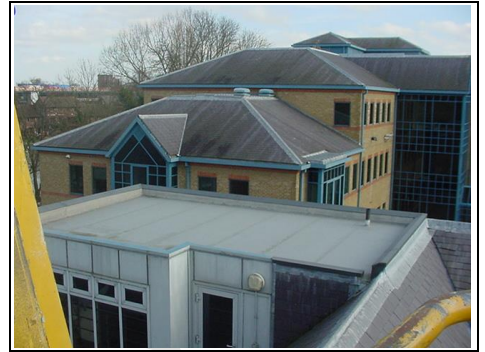
## Roof - External

| DESCRIPTION | CONDITION | ACTION REQUIRED |
|--|--|--|
| <b>Main roof:</b><br><br>Pitched clad with slate<br> | General staining and some tiles displaced. Repairs noted.<br> | Make wind and watertight |
| <b>Flat roof:</b><br><br>Mono-ply roof<br> <br><br>Roof that has been replaced with mono-ply roof<br> | Mono-ply roof needs a clean<br> <br><br>Leak around air conditioning unit<br> | Provide landlord with guarantee for new mono-ply roof. |

| <p>We are advised high level flat roof has been repaired</p> | <p>Poorly bonded area of felt</p> <p>Safety handrail on roof needs redecorating</p> | <p>Clean and repair leaks visible internally. We would recommend an entire new roof with a guarantee as the safest way of making this area watertight.</p> <p>Repair, prepare and redecorate.</p> |
| <p><b>Gutters and Downpipes:</b></p> <p>Metal box gutters</p> | <p>Gutters overflowing which is an inherent defect</p> | <p>Ensure all gutters are watertight and falling towards the downpipe and clear.</p> <p>Repair downpipes and secure as necessary, ensure downpipes are clean and clear.</p> <p>Redecorate.</p> |

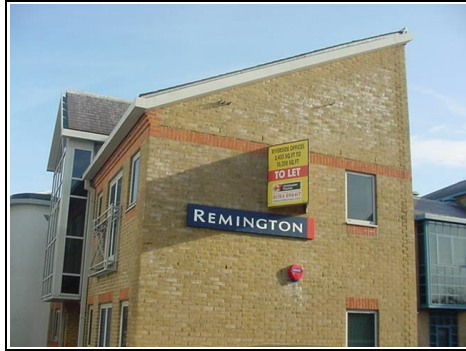
Front view (roadside)

| DESCRIPTION | CONDITION | ACTION REQUIRED |
|---|---|--|
| <b>Walls:</b><br><br>Stretcher bond brickwork | High level efflorescence<br><br><br>Expansion joint<br> | Clean efflorescence to bricks |
| <b>External Detailing:</b><br><br><b>Windows:</b><br>Pre-finished aluminium double glazed windows | Dated | Clean and if necessary repair, prepare and redecorate. |

| <b>Signage:</b> | Old Remington signage | Remove branded signage and any non-essential signage |

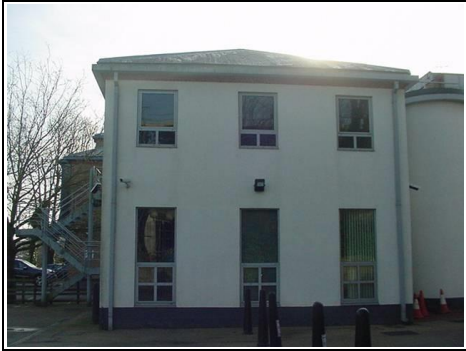
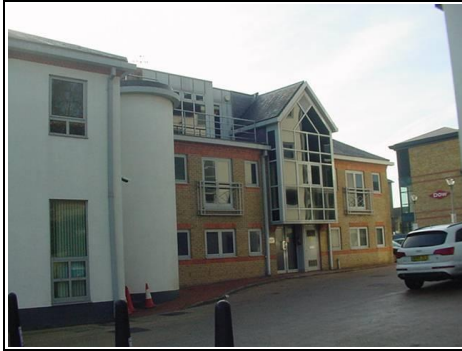
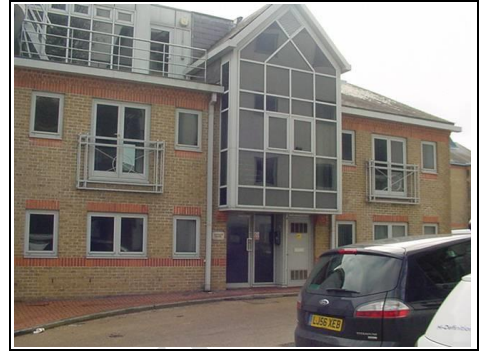
## Left External Elevation (Front Access)

| DESCRIPTION | CONDITION | ACTION REQUIRED |
|---|--|---|
| <b>Gutters and Downpipes:</b><br><br>Box gutter | Paint flaking to box gutter near central and front area<br><br> | Clean or repair, prepare and redecorate box gutter.<br><br>Ensure all gutters are watertight and falling towards the downpipe and clear.<br><br>Repair downpipes and secure as necessary, ensure downpipes are clean and clear. |
| <b>Walls:</b><br><br>Painted render | Dated.<br><br>Hairline cracking near flat roof area.<br><br>Areas of blown and blistered render to base we assume | Repair, prepare and redecorate render.<br><br>Blown render likely to need removal to the line that is |

| | <p>from recent flooding</p> <p>Blown render hidden</p> | <p>approximately 200mm from the ground level in some areas but generally repair.</p> |
| <p><b>External Detailing:</b></p> <p><b>Windows:</b><br/>Pre-finished aluminium double glazed windows</p> <p>Juliet balconies</p> <p>Moss</p> | <p>Dated meaning that they haven't been regularly painted.</p> <p>Moss embedded on windows</p> <p>Seals have failed</p> | <p>Clean metal windows and window sills and check condition. May have to repair, prepare and redecorate.</p> <p>Replace double glazed windows with broken seals.</p> |

| <p><b>Doors:</b></p> <p>Entrance doors</p> <p>Fire exit door</p> | <p>Dated meaning that they haven't been regularly painted.</p> <p>Metal area rusting, steps missing and rust stains around handrail</p> <p>Missing fire exit steps</p> <p>Rust to metal fire escape</p> | <p>Clean. If not cleaned to suitable standard may have to repair, prepare and redecorate.</p> <p>Repair, prepare and redecorate.</p> <p>Replace steps.</p> |
| <p><b>Services:</b></p> <p>Gas meter cupboard</p> | <p>Broken doors to gas unit</p> | <p>Add door</p> |
| <p><b>Brick paviors</b></p> | <p>Moss</p> <p>Drop in brick paviors</p> | <p>Remove moss</p> <p>Make good</p> |

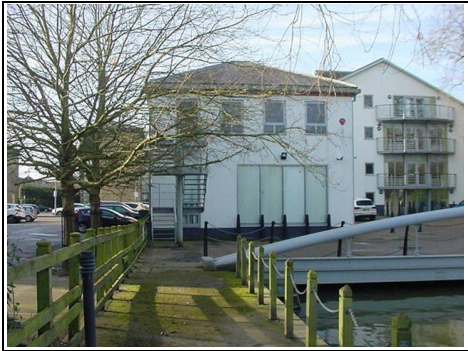
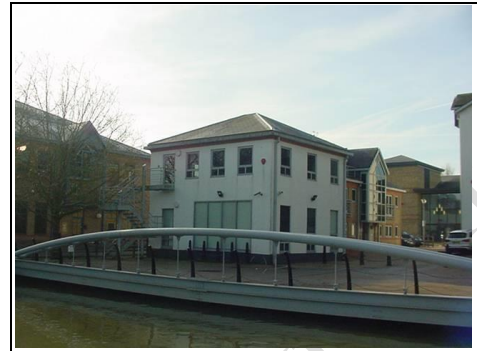
## Rear External Elevation

| DESCRIPTION | CONDITION | ACTION REQUIRED |
|---|--|--|
| <b>Gutters and Downpipes:</b><br><br>Box gutter | Impact damage and blue paint grinning through. | Clean or repair, prepare and redecorate.<br><br>Ensure all gutters are watertight and falling towards the downpipe and clear.<br><br>Repair downpipes and secure as necessary, ensure downpipes are clean and clear. |
| <b>Walls:</b><br><br>Render<br><br>Pattern staining | Damaged render at base | Repair, prepare and redecorate. |

| <p><b>External Detailing:</b></p> <p><b>Windows:</b><br/>Pre-finished aluminium double glazed windows</p> | <p>Film on windows coming off on first floor window</p> <p>Sills heavily stained and marked</p> | <p>Clean. If not cleaned to suitable standard may have to repair, prepare and redecorate.</p> |
| <p><b>Doors:</b></p> <p>Fire exit</p> | <p>Fire exit deteriorating</p> | <p>Repair, prepare and redecorate.</p> |

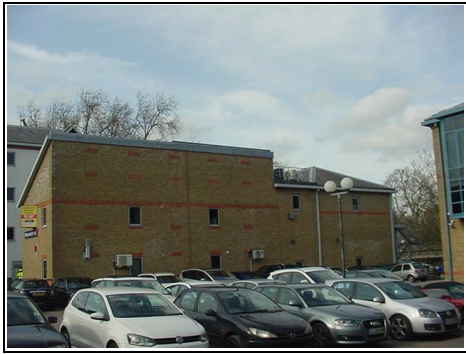
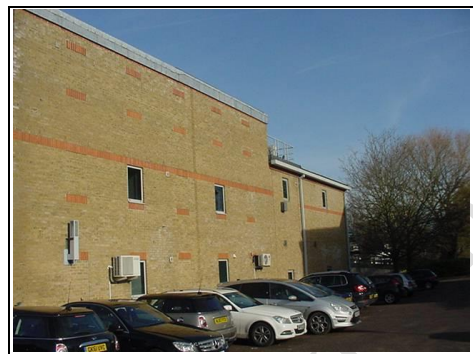
## Right External Elevation

| DESCRIPTION | CONDITION | ACTION REQUIRED |
|---|---|--|
| <b>Gutters and Downpipes:</b><br><br>Box gutter | Damaged downpipe<br> | Clean or repair, prepare and redecorate.<br><br>Ensure all gutters are watertight and falling towards the downpipe and clear.<br><br>Repair downpipes and secure as necessary, ensure downpipes are clean and clear. |
| <b>Walls:</b><br><br>Stretcher bond brickwork<br><br>Feature bricked up windows part of original design<br><br>Expansion joints | Efflorescence<br> | Clean |

| | Paint on brickwork<br> | Clean. |
| <b>Services:</b><br><br>Two cooler units<br><br>Several vents | One vent out of square<br> | Tests and reports required.<br><br>Re-align vent |

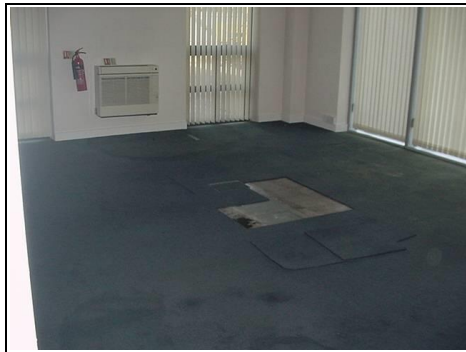
Open plan office

| DESCRIPTION | CONDITION | ACTION REQUIRED |
|--|---|---|
| <b>Ceilings:</b><br><br>Square suspended ceiling grid | Water damage to far left side<br><br> | Repair leak. Replace ceiling tiles to match existing tiles. It may be necessary to replace all ceiling tiles. |
| <b>Walls:</b><br><br>Painted | Dated. Marked and old fixing points. | Repair, prepare and redecorate |
| <b>Floors:</b><br><br>Carpets | Marked and dated | Clean or replace. |

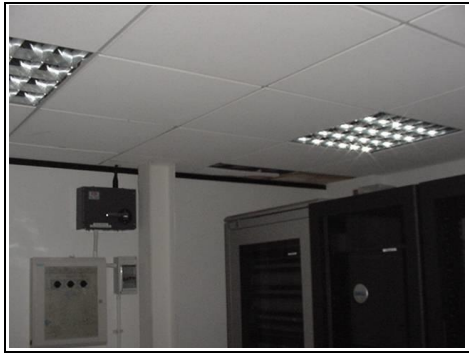
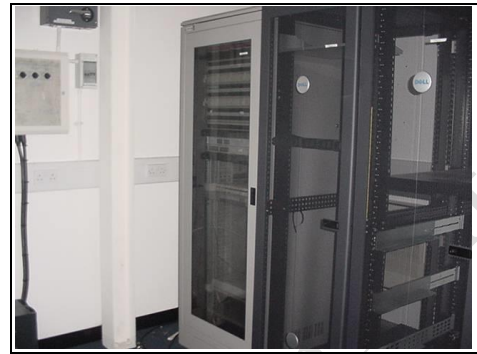
## Computer Room

| DESCRIPTION | CONDITION | ACTION REQUIRED |
|---|---|--|
| <b>Ceilings:</b><br><br>Suspended ceiling tiles | Some missing | Replace ceiling tiles ensuring they match. |
| <b>Walls:</b><br><br>Painted | Old fixing points. | Repair, prepare and redecorate |
| <b>Floors:</b><br><br>Carpet | Marked | Clean or replace |

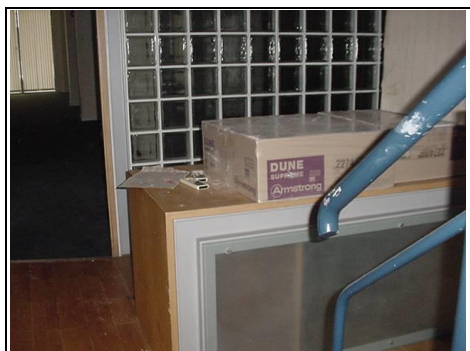
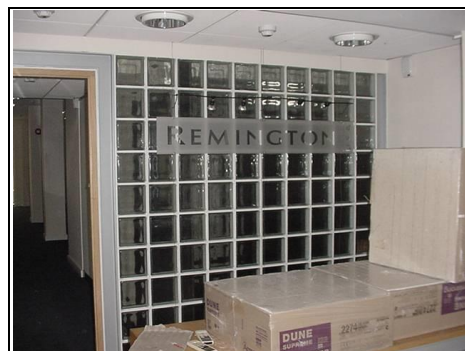
## Reception Area

| DESCRIPTION | CONDITION | ACTION REQUIRED |
|---|--|--|
| <b>Ceilings:</b><br><br>Plasterboard to majority of area.<br><br>Suspended ceiling tiles above reception. | Dated | Repair, prepare and redecorate<br><br>Clean. |
| <b>Walls:</b><br><br>Painted | Dated | Repair, prepare and redecorate |
| <b>Floors:</b><br><br>Timber floor | Flood damage<br><br>Water coming up has affected the floor, cupping of the floor and distortion<br><br> | Replace |

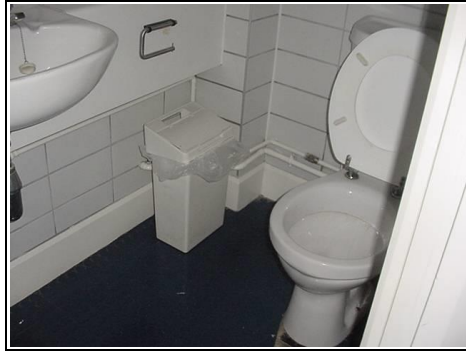
Gents Toilets

| DESCRIPTION | CONDITION | ACTION REQUIRED |
|--|---|---|
| <b>Ceiling:</b><br><br>Painted | Dated | Repair, prepare and redecorate. |
| <b>Walls:</b><br><br>Tiled | Some tiles come away<br> | Repair. |

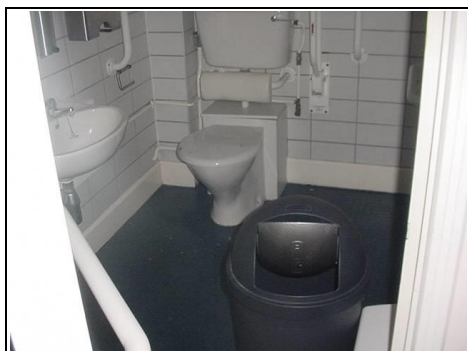
Ladies/Disabled Toilets

| DESCRIPTION | CONDITION | ACTION REQUIRED |
|--|---|---|
| <b>Ceiling:</b><br><br>Painted | Dated | Repair, prepare and redecorate. |
| <b>Walls:</b><br><br>Tiled | Tiles off wall<br> | Repair and deep clean. |

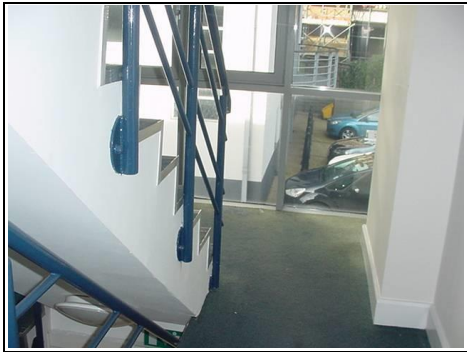
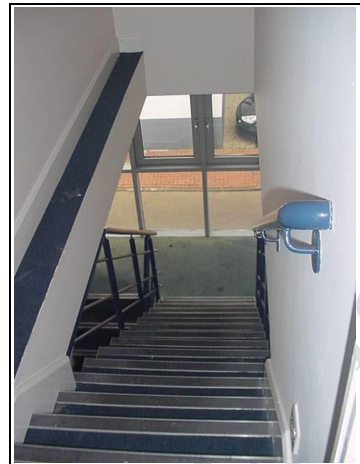
## Stairs/Landing

| DESCRIPTION | CONDITION | ACTION REQUIRED |
|---|---|--|
| <b>Ceilings:</b><br>Plasterboard | Dated | Repair, prepare and redecorate |
| <b>Walls:</b><br>Painted | Dated | Repair, prepare and redecorate |
| <b>Floors:</b><br>Carpet and nosings | Dated and marked | Clean or replace. |
| <b>Detailing:</b><br><b>Windows:</b><br><b>Doors:</b> | Dated<br><br>Dated | Clean or repair, prepare and redecorate.<br><br>Clean |

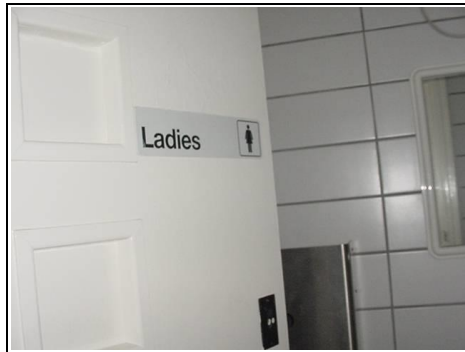
Ladies toilets

| DESCRIPTION | CONDITION | ACTION REQUIRED |
|---|---|--|
| <b>Ceiling:</b><br><br>Painted | Dated | Repair, prepare and redecorate. |
| <b>Detailing:</b><br><br><b>Windows:</b><br><br><b>Doors:</b><br><br>Painted panel door | Dated<br><br>Dated | Clean or repair, prepare and redecorate<br><br>Clean |

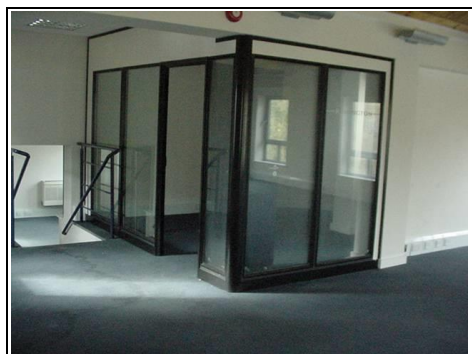
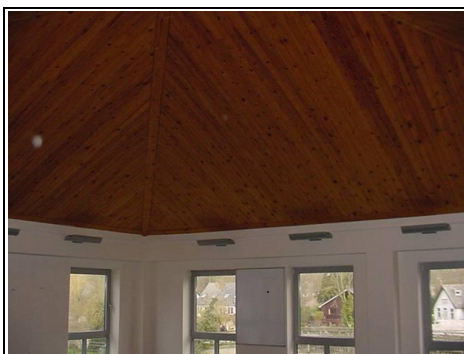
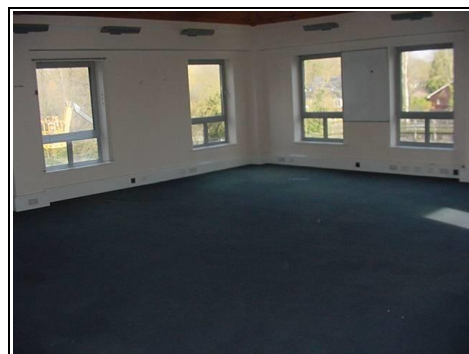
## Riverside Open Plan Office

| DESCRIPTION | CONDITION | ACTION REQUIRED |
|---|---|---|
| <b>Ceilings:</b><br><br>High level timber boarded ceiling<br><br><br>Ceiling tiles | Minor marks such as paint on it for example to the fire exit to front of property<br><br>Water leaks to left hand side. We are advised the roof has now been replaced.<br><br> | Clean, re-stain if necessary.<br><br><br>Replace ceiling tiles ensuring they match. |
| <b>Glazed meeting room:</b><br><br>Suspended ceiling tiles<br><br>Area of plasterboard ceiling with circular lights | Marks and indents | Repair or replace. |
| <b>Walls:</b><br><br>Painted | Dated. Marked where notices, etc have been stuck on | Remove fixtures and fittings. Repair, prepare and redecorate |

| | Whiteboard<br><br>Minor marks in glazed office near window | Remove fixtures and fittings<br><br>Repair, prepare and redecorate. |
| <b>Floors:</b><br><br>Carpet | Stained<br> | Replace. |

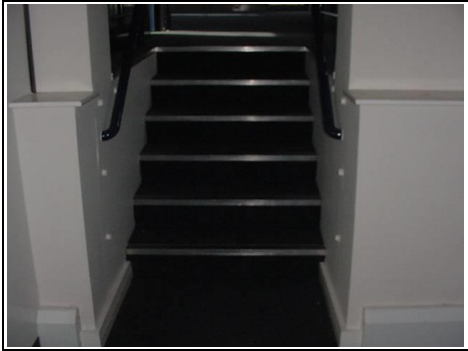
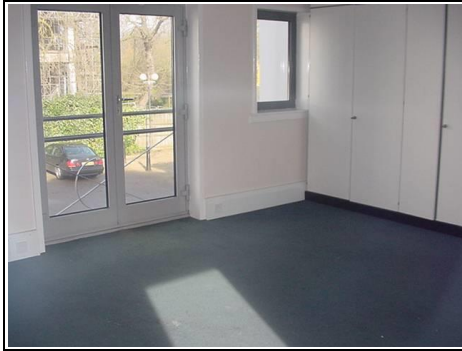
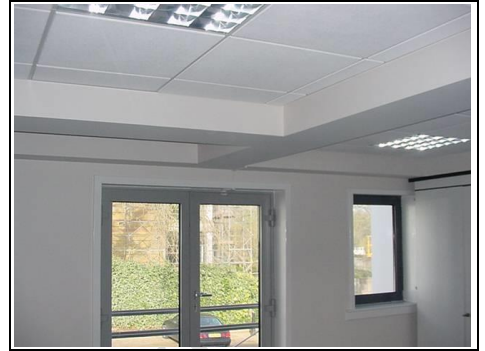
## Middle Office (down steps)

| DESCRIPTION | CONDITION | ACTION REQUIRED |
|---|---|---|
| <b>Ceilings:</b><br>Suspended ceiling tiles | Some marks | Repair, prepare and redecorate |
| <b>Walls:</b><br>Painted | Marked and old fixing points | Repair, prepare and redecorate |
| <b>Floors:</b><br>Carpet | Marked | Clean or replace. |
| <b>Detailing:</b><br><b>Windows:</b><br>Windows<br><b>Doors:</b><br>Double door to Juliet balcony | Dated<br><br><br>Dated | Clean or repair, prepare and redecorate<br><br><br>Repair, prepare and redecorate |

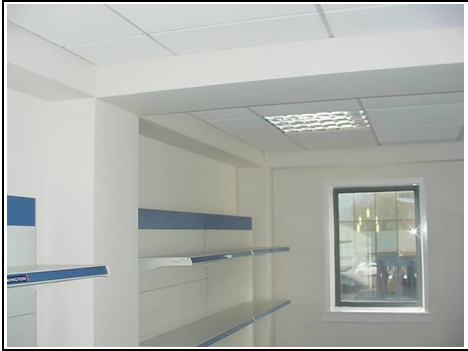
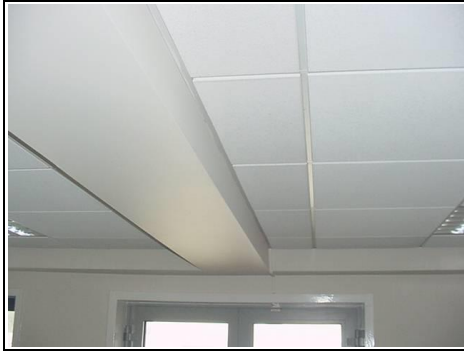
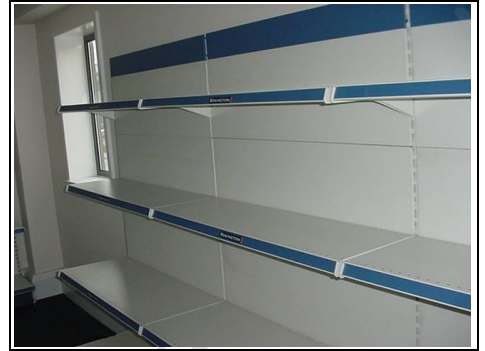
## Roadside Office

| DESCRIPTION | CONDITION | ACTION REQUIRED |
|--|---|---|
| <b>Ceilings:</b><br><br>Suspended ceiling tiles | Marked. Mixture of different coloured ceiling tiles | Clean. Replace with matching ceiling tiles. |
| <b>Walls:</b><br><br>Painted | Minor marks and dated. | Repair, prepare and redecorate |
| <b>Floors:</b><br><br>Carpet | Dated | Clean or replace. |
| <b>Detailing:</b><br><br><b>Windows:</b><br><br>Four windows | Dated | Clean or repair, prepare and redecorate |

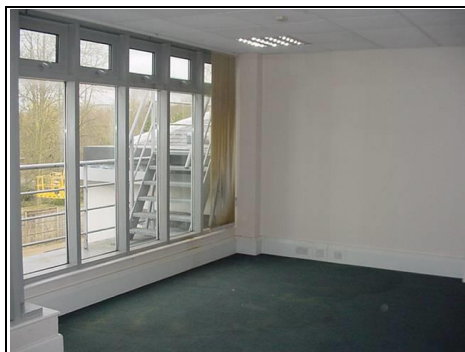
Front office gives access onto  
roofs

| DESCRIPTION | CONDITION | ACTION REQUIRED |
|---|--|--|
| <b>Ceilings:</b><br><br>Suspended ceiling tiles<br>Roof window<br>Access door to roof | Water staining and marked<br> | Make sure roof is watertight before any work is carried out.<br><br>Replace.<br><br>Clean.<br><br>Clean, repair, prepare and redecorate. |
| <b>Walls:</b><br><br>Painted | Minor marks to left side | Repair, prepare and redecorate |
| <b>Floors:</b><br><br>Carpet | Dated | Clean or replace. |

| Service conduit skirting | Broken sockets | Replace. |

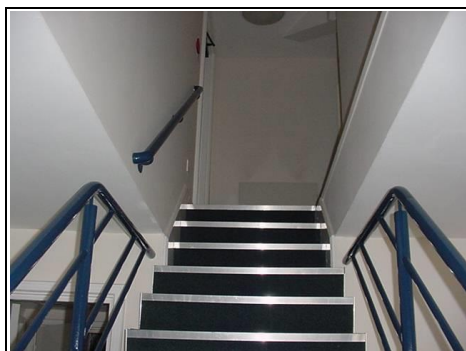
Stairs

| DESCRIPTION | CONDITION | ACTION REQUIRED |
|--|---|--|
| <b>Ceilings:</b><br><br>Plasterboard<br><br>Beams plastered over | Dated<br><br>Dated | Repair, prepare and redecorate |
| <b>Walls:</b><br><br>Painted | Dated | Repair, prepare and redecorate |
| <b>Floors:</b><br><br>Carpet | Dated and marked | Clean or replace. |
| <b>Detailing:</b><br><br><b>Windows:</b><br><br><b>Doors:</b> | Dated<br><br>Dated | Clean or repair, prepare and redecorate<br><br>Clean |

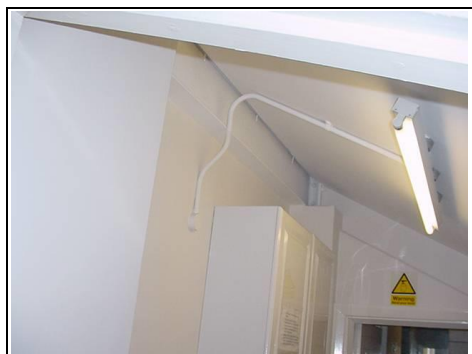
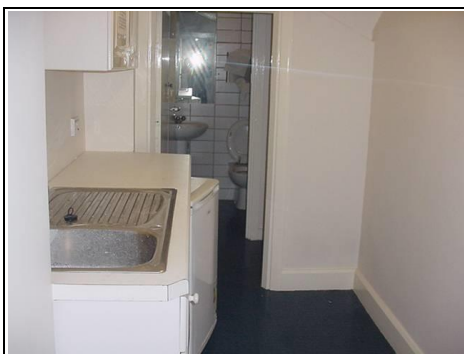
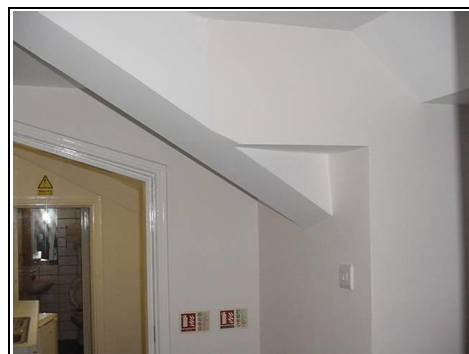
## **Kitchenette (Roadside)**

| DESCRIPTION | CONDITION | ACTION REQUIRED |
|---|---|--|
| <b>Ceiling:</b><br>Plasterboard angled ceiling | Dated | Repair, prepare and redecorate. |
| <b>Walls:</b><br>Painted | Dated and marked | Repair, prepare and redecorate.<br>Recommend adding tiled splashback. Not a lease requirement but the sink is likely to be used when the painting and decorating is being carried out and it can get marked. |

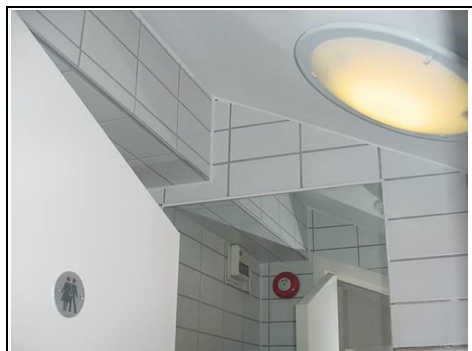
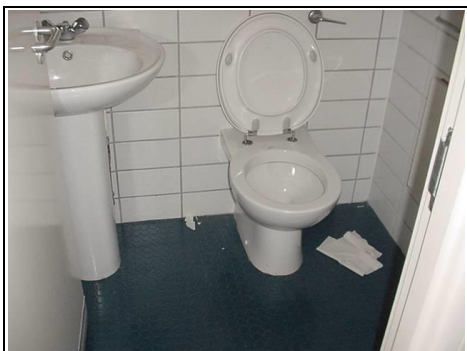
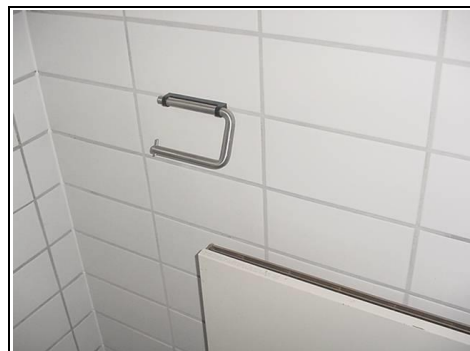
## **Unisex Toilet and Lobby (Roadside)**

| DESCRIPTION | CONDITION | ACTION REQUIRED |
|---|--|---|
| <b>Ceiling:</b><br>Painted sloping ceiling | Dated | Repair, prepare and redecorate. |
| <b>Walls:</b><br>Tiled<br>Painted | Dated<br>Hairline cracking in lobby around door leading to roof area | Clean.<br>Repair, prepare and redecorate. |
