# SCHEDULE OF CONDITION

London Borough of Hillingdon

# **INTERNAL** **UNIT D, FIRST FLOOR**

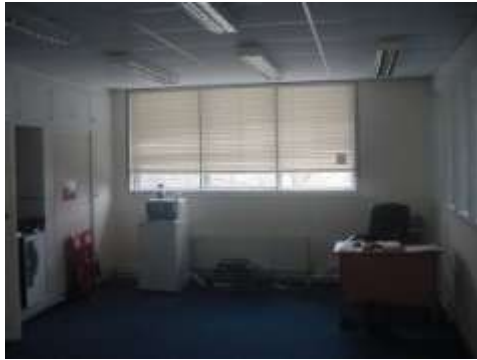
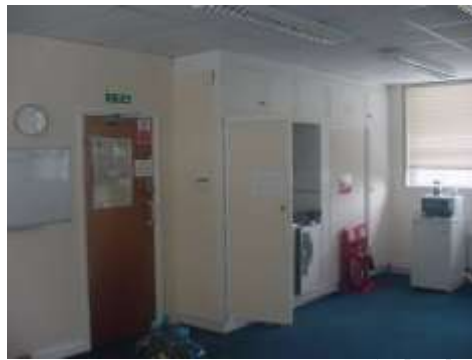
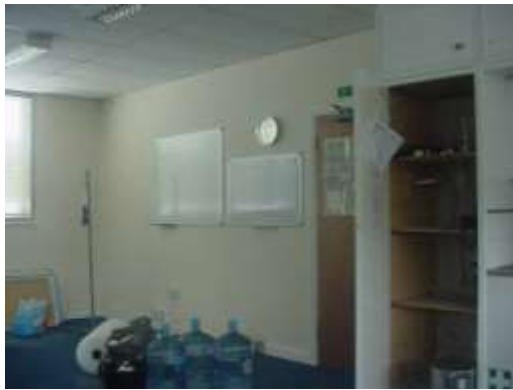
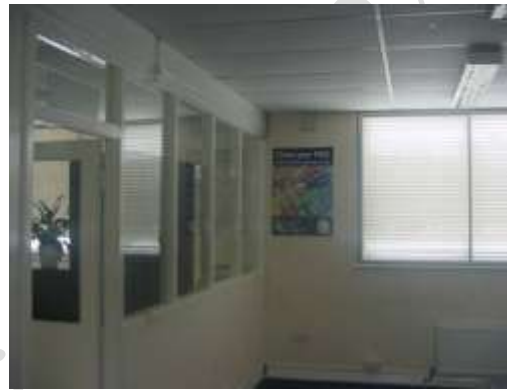
## Main open plan office

DESCRIPTION	CONDITION	ACTION REQUIRED
<p><b>Ceilings:</b></p> <p>Rectangular suspended ceiling tiles Visible ceiling grid Seven Category Two style ceiling lights</p> <p>Passive infrared alarm system added by tenant</p>

<p>Hole in ceiling where partition was removed</p>	<p>Repair or replace</p> <p>Clean</p> <p>Remove alarm system or get agreement with Landlord that it can remain</p>

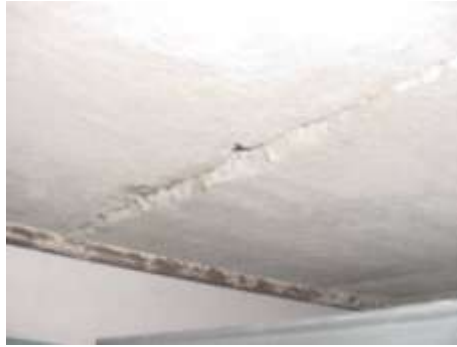
Random areas inspected, water penetration noted, could also be cold bridging/condensation.

Concrete slab system with minor water penetration

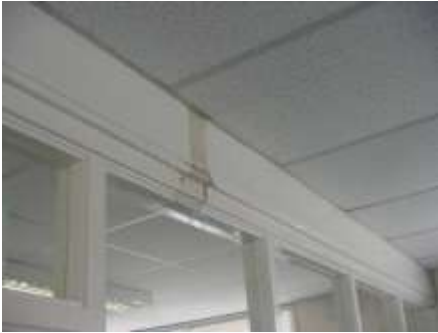
<p><b>Walls:</b></p> <p>Papered and painted</p> <p>Whiteboards on walls</p>	<p>Marked</p>

<p>Marked where partition removed on left hand side</p> <p>Marks where partition has been removed on right hand wall</p>	<p>Repair, prepare and redecorate.</p> <p>Make good and/or replace partition</p> <p>Remove if client fixture and fitting</p>
<p><b>Floors:</b></p> <p>Carpet</p>	<p>Dip in floor to front left hand side</p>	<p>Make good floor levels. Clean and/or replace.</p>
<p><b>Detailing:</b></p> <p>Windows: Two aluminium windows in timber frames with secondary glazing</p> <p>Doors: One veneer door on left hand side</p> <p>Two painted doors with vision panels and associated frame</p> <p>Skirting:</p>	<p>Reveals are marked. Gap between external window and internal secondary glazing is dirty</p> <p>Marked</p>

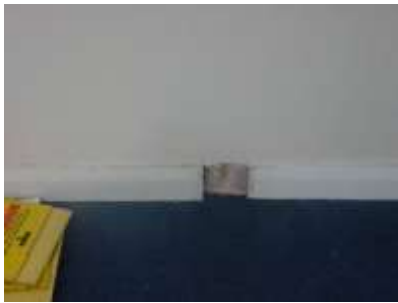
<p>Skirting needs repair on left hand wall</p>	<p>Clean. Repair, prepare and redecorate the reveals.</p> <p>Clean and/or replace</p> <p>Repair, prepare and redecorate.</p> <p>Repair, prepare and redecorate.</p>

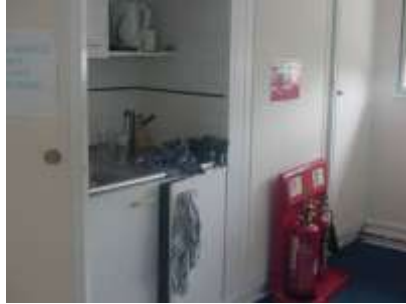
**Kitchenette Area**  
**Left hand side rear of main office**

DESCRIPTION	CONDITION	ACTION REQUIRED
<b>Ceilings:</b> As main office	Mark to ceiling	
<b>Walls:</b> As main office		
<b>Floors:</b> As main office		
<b>Kitchen Equipment:</b> Cupboards  Stainless steel sink and drainer	Handles missing	Replace handles, general clean  Clean
<b>Services:</b> Ideal wall mounted boiler  Copper pipe runs along rear wall		Gas Safe certificate required

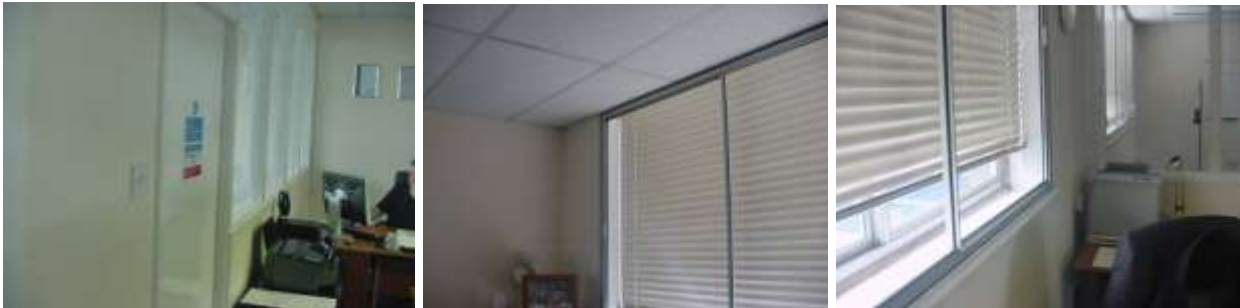
## Office front right

DESCRIPTION	CONDITION	ACTION REQUIRED
<p><b>Ceilings:</b></p> <p>Rectangular suspended ceiling tiles Two Category Two style ceiling lights</p>		Clean
<p><b>Walls:</b></p> <p>Painted and papered</p>	  <p>Horizontal cracking to right hand side Marked</p>	Repair, prepare and redecorate
<p><b>Floors:</b></p> <p>Carpet</p>		Clean or replace

<p><b>Detailing:</b></p> <p>Windows: Aluminium window in timber frame with secondary glazing</p> <p>Doors: Interlinking door to rear right hand office which is locked</p>	<p>Two partitions with vision panels at high level</p>

<p>Ironmongery missing</p>	<p>Clean and/or redecorate between window and secondary glazing.</p> <p>Clean and/or redecorate</p> <p>Replace ironmongery</p>
<p><b>Services:</b></p> <p>One data point added by client</p>		<p>Client to agree with landlord or remove</p>

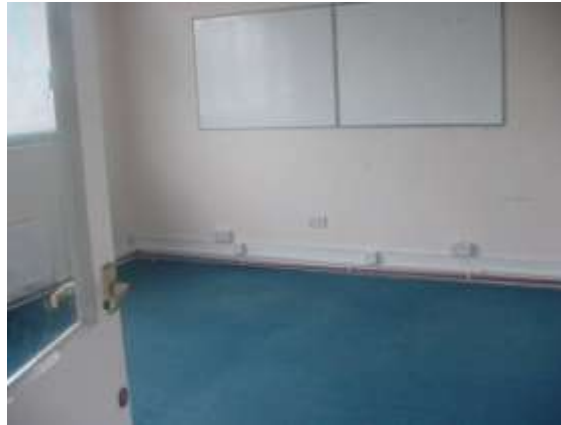
**Office rear right**

DESCRIPTION	CONDITION	ACTION REQUIRED
<p><b>Ceilings:</b></p> <p>Rectangular suspended ceiling tiles Two Category Two style ceiling lights</p>		Clean
<p><b>Ceiling void:</b></p> <p>Right hand corner, left hand corner</p>	<p>Concrete slab system with minor water penetration</p>

<p>Dampness to rear left hand corner</p>	
<p><b>Walls:</b></p> <p>Dry lined walls papered and painted</p>	<p>Vertical crack to right hand wall</p> <p>Marked</p>	Repair, prepare and redecorate.

<p><b>Floors:</b></p> <p>Carpet</p>	<p>Worn areas</p>	<p>Clean or replace</p>
<p><b>Detailing:</b></p> <p>Windows: One aluminium window in timber frame with secondary glazing</p> <p>Vision panels</p> <p>Doors: Interlinking door to front right hand office which is locked</p> <p>Skirting:</p>

<p>Ironmongery missing</p>	<p>Clean</p> <p>Replace ironmongery</p> <p>Clean</p>
<p><b>Services:</b></p> <p>Three data points on right hand side added by client</p> <p>Two data points on left hand side added by client</p>		<p>Client to agree with landlord or remove</p>

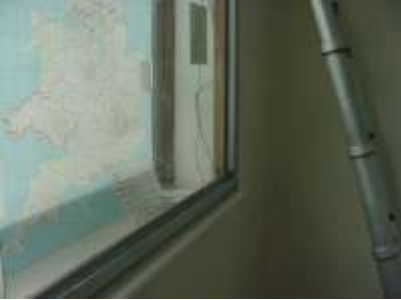
<p>Gap between external window and internal secondary glazing is dirty</p>
