# COMMERCIAL BUILDING SURVEY

**Berkshire**

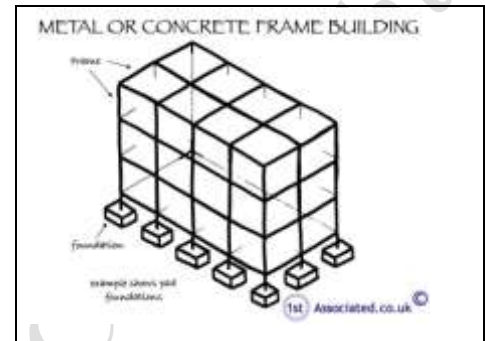
Before we start this section we first of all want to explain that this is a building that is built on a structural frame which gives structural support and from which other elements such as the walls, windows and floors etc are supported in one way or another, please see sketch.

Our main concern is rusting that we can see within the structural frame. Whilst the rusting seen isn't of such a condition that we believe it will cause structural problems it does mean that there may be future issues.

**ACTION REQUIRED:** Open up structure to establish condition of structural frame and carry out sonic testing or similar to confirm the condition of the structural frame.

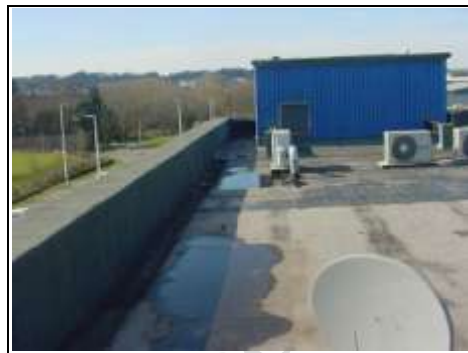
The property has a large flat roof with parapet walls. The main problem we can see with the flat roof is that a flat roof should have a fall of approximately fifteen degrees and it is also bedded onto wood wall slab, a product known to have problems. This was a relatively common product in the 1960's and 1970's however it is no longer used or considered desirable to have in your structure.

General view of the roof

**ACTION REQUIRED:** We would recommend re-roofing and that insulation is added with a high performance felt and a fall added to the entire roof. At the same time we would build up the firewalls internally.

**ANTICIPATED COST:** In the region of £25,000 - £40,000. We would also take the opportunity of replacing the wood wall slab as this will make the future saleability/risk of it causing problems much less; please obtain quotations.

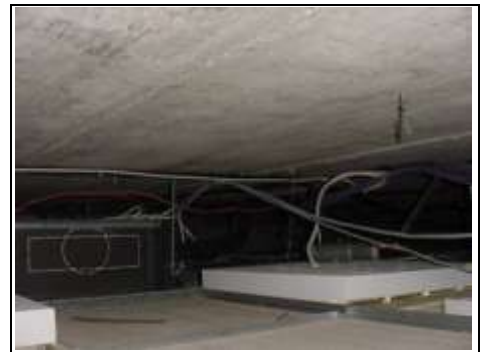
Finally some of the roof may be formed on a pre-cast concrete slab; these should be checked to ensure that they are adequate.

Underside of concrete slab on left hand side of building

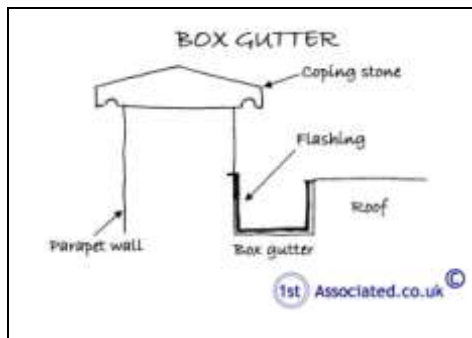
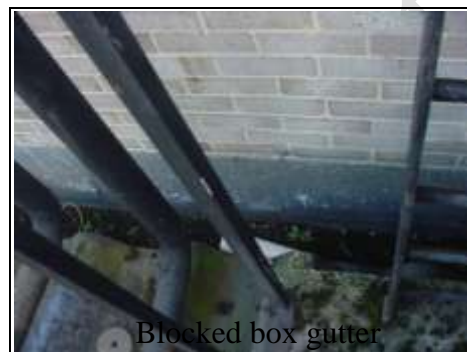
There is a box gutter where the main building meets the adjoining building to the left hand side where the fire escape is. This does not look to have been maintained for some time.

**ACTION REQUIRED:** General maintenance required and is likely to require waterproofing.

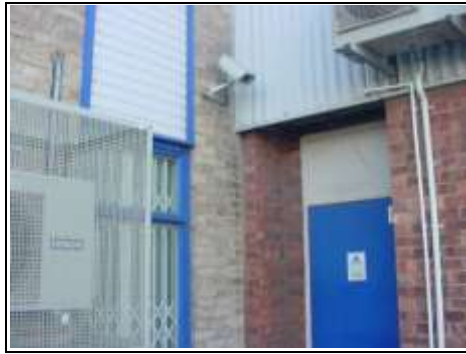
There are two fire exits to the property, one to the left hand side and one to the right hand side. Both need a full check to ensure they have a firewall in place.

Fire exit to rear left hand side of property

**ACTION REQUIRED:** Both the left and right hand fire exits need checking to ensure that the protection provides adequate fire checks/fire stops between the staircase and the main offices. The present owners should also have a diagram indicating where any other firewalls are, these need to be obtained. This looks to have been poor quality workmanship.

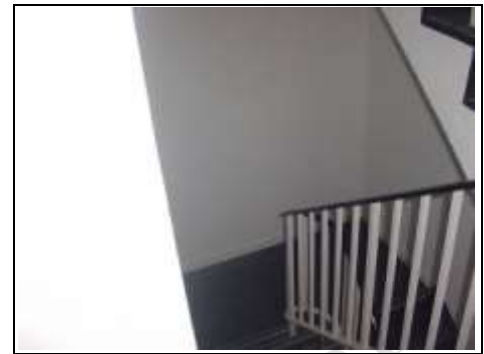
Right hand side fire escape

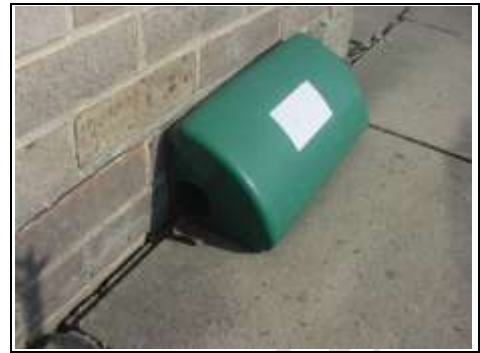
There seems to be a rodent problem around the property from the deterrent boxes although we are sure the owners will be able to elaborate further about the reasons these are present.

Rodent deterrent boxes

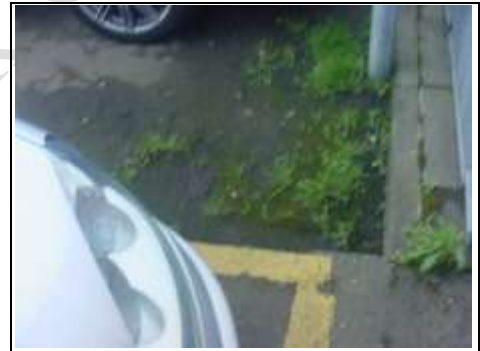
The car park was full at the time of the survey which meant we had a limited view. However what we could see nearer the offices appeared to be a block in the drains.

Drain not working to front of property

**ACTION REQUIRED:** General jetting of drains and close circuit TV camera reports.

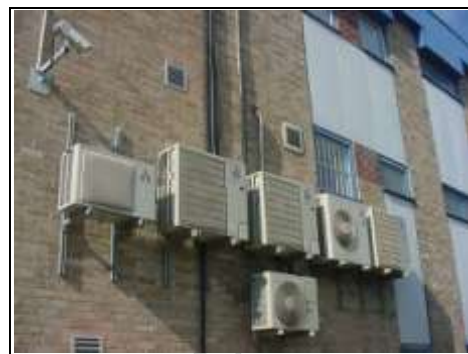
Generally properties of this age are not as energy efficient as modern properties. The building is currently being run on an electric air conditioning system although the original boiler and radiator system is still in place. It is likely to be costly to run.

Air conditioning units on right hand side of property

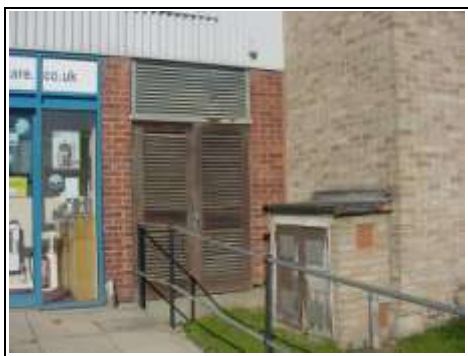
Boiler room

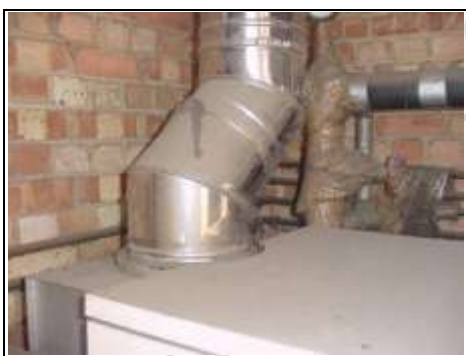
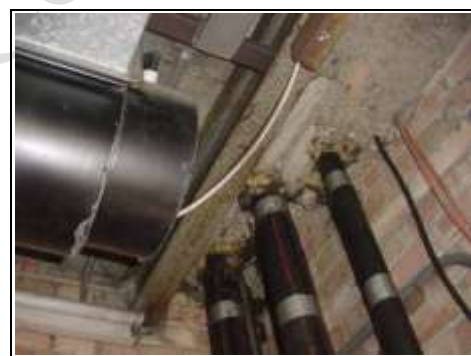
Inside boiler room

**ACTION REQUIRED:** Obtain information with regard to the cost of services. We would also recommend looking at the energy efficiency of the building and we have suggested that insulation is added to the roof and would also suggest it is added to the walls if it is not already.

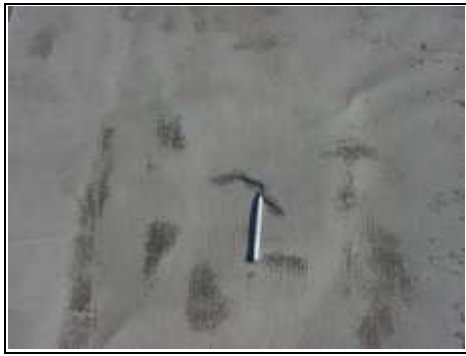
Tear in felt

**ACTION REQUIRED:** We would recommend a new roof is installed including decking with insulation and a high performance felt. This is known as a Warm Roof.

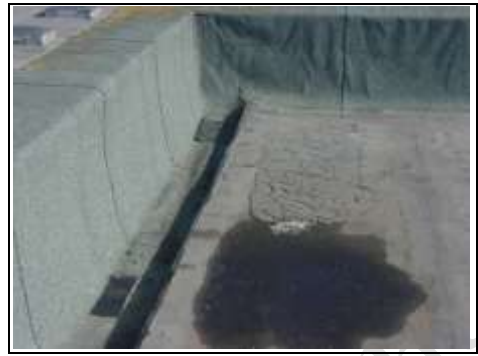
Puddle on roof

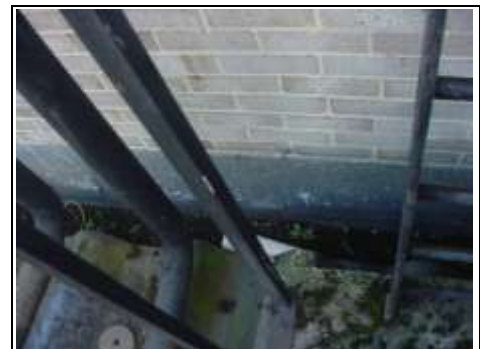
Blocked box gutter

**ACTION REQUIRED:** We like the concept of the flat gutter which is a large gutter however it does need to be maintained. In this case it hasn't been maintained and needs to be unblocked.

**ANTICIPATED COST:** A few hundred pounds and a check and repair as necessary.

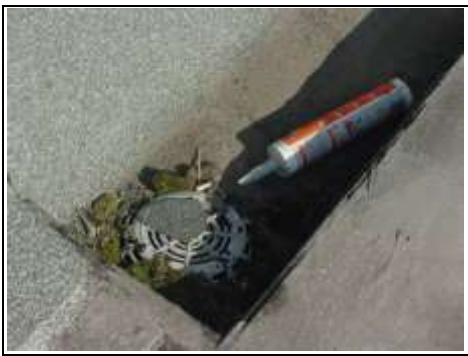
Downpipe outlet.

As you can see this hasn't been cleaned for some time.

**ACTION REQUIRED:** We would recommend general cleaning of the outlets

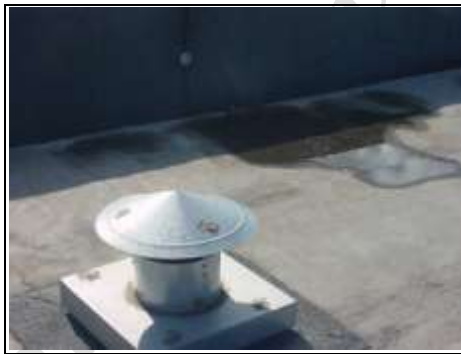
Ponding to roof

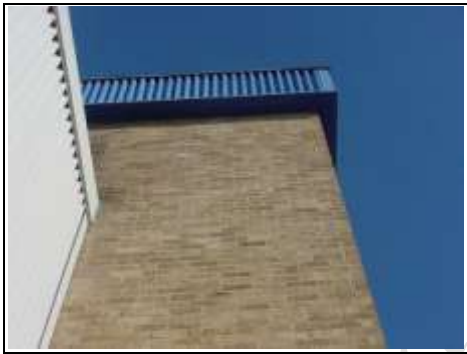
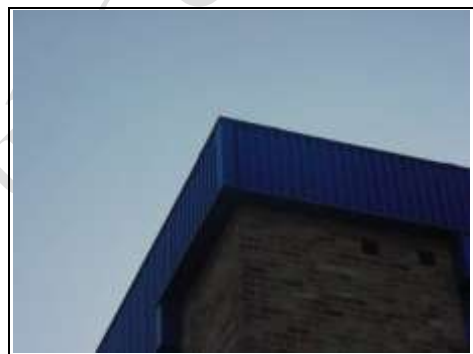
The fascias and soffits are clad in metal. We have commented upon these within the Walls Section. What we could see was in average condition for its age, type and style. They form the parapet wall which is covered with felt.

Fascia and soffit cladding

**ACTION REQUIRED:** We would recommend opening up one of these parapet walls to understand its construction.

**ANTICIPATED COST:** A few hundred pounds plus repair costs. Quotations required.

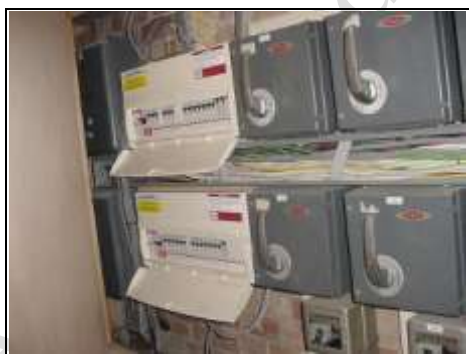
Electrics in store cupboard

**ACTION REQUIRED:** We would recommend a specialist electrical contractor is appointed prior to the legal commitment to purchase this property to offer estimates to re-wire to an Institute of Electrical Engineers (IEE) standard.

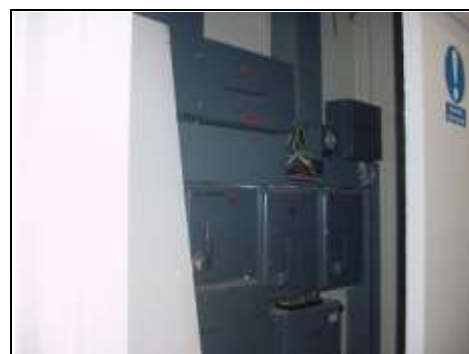
Bank of electrics to left hand side  
ground floor

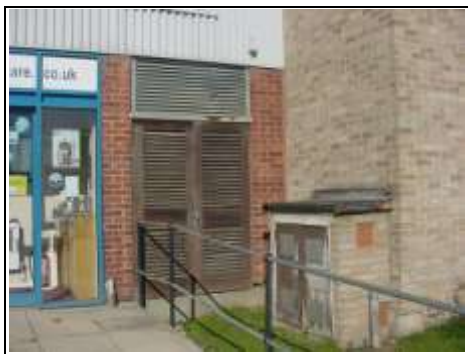
Boiler room

We are advised this is all electric via the air conditioning units. Although there is an old boiler room this is no longer used yet the radiators are still in position. You need to decide how you wish to heat the property.

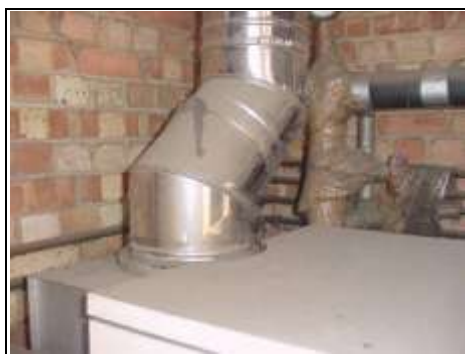
Inside boiler room

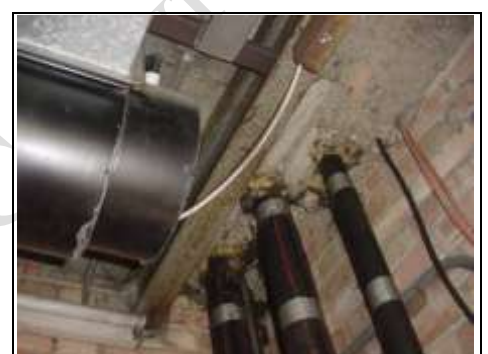
Inside boiler room

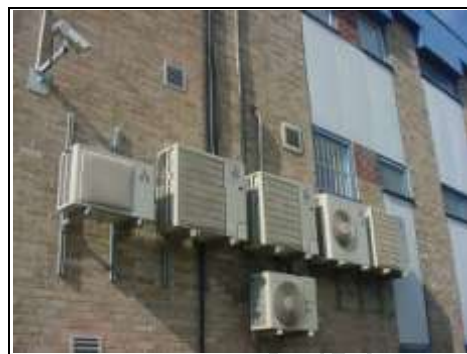
The air conditioning units can be seen on the right hand side of the property.

Air conditioning units on right hand side of property
