COMMERCIAL BUILDING SURVEY

London Borough of Barnet

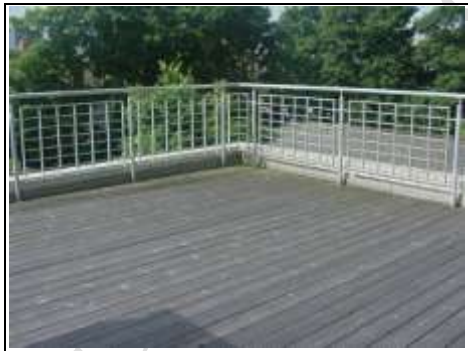
Decking covering most of the roof

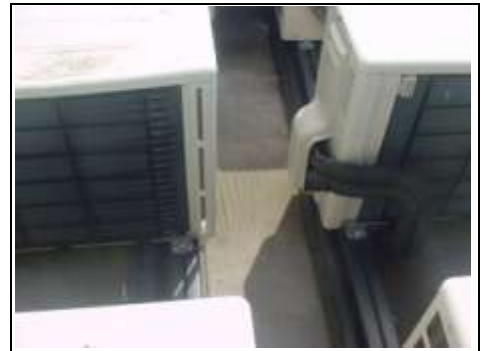
Asphalt roof finish only visible around air handling units

In our experience, where you get a leak with an asphalt roof, it is very difficult to find out where it is coming from without using very specialist equipment and of course you would have to remove all the decking.

ACTION REQUIRED AND ANTICIPATED COST: As mentioned, we have had a very limited view of the roof but bearing in mind the problems that have occurred next door we would recommend that you put aside the sum of £5,000 to £10,000 for the possible removal of the entirety of decking, a full test and report of the surface (you can use dye tests and also electronic testers) and most importantly, you get a full guarantee from the developers for at least twelve months.

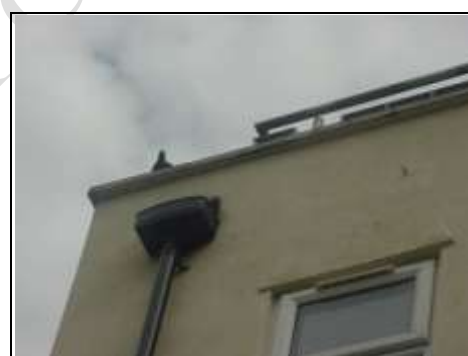
We checked areas of the coping stone and noted that the drip detail is very close to the main wall. This could be an additional problem that is causing dampness coming through the property.

Parapet wall at high level

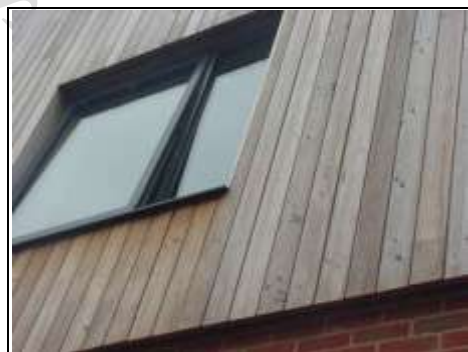
Example of timber rain cladding on another building giving protective layer to blockwork beneath

1. Regular maintenance in the form of the sealing of any cracks. This would initially be a few thousand pounds. It is likely to need a tower scaffolding or similar. It is likely that over time the amount of cracks will reduce, however we cannot guarantee this and our other concern is that the scaffolding will of course block the access road unless you get a specialist scaffolding which will be expensive.
2. An alternative we know what has been used, particularly by local authorities where they have problem buildings of this type, is to use an over cladding or a rain cladding. This is a system which puts a screen in front of the existing render. This solution can work well, although we are aware of problems with rain cladding.

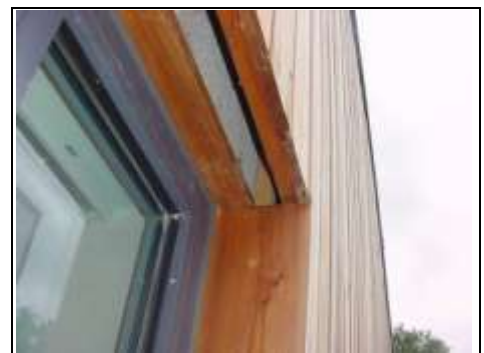
Example of close up of rain cladding on another building

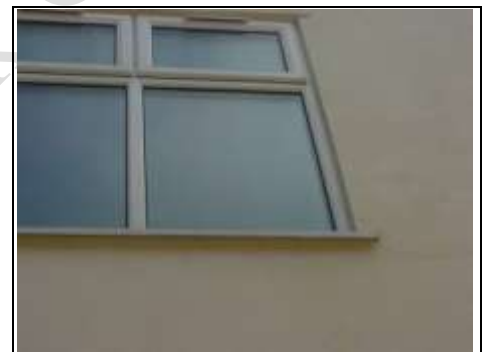
The windows to the left hand side (all directions given as you face the property from the front door entrance) are opaque, indicating that someone has applied for a right of light to the side elevation. They may be proposing or have development rights.

Opaque glass on left hand side

ACTION REQUIRED: Your legal adviser needs to be very careful about this point and to check if development is going to take place and if so how, what and when.

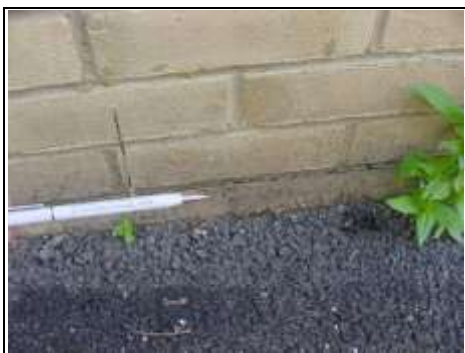
We noted there is little difference between the outside and the inside area, which does of course mean that you can get dampness in the property and could be prone to flooding.

Damp proof course too low

ACTION REQUIRED: Lower the ground level around the property; this may or may not be possible depending upon ownership.

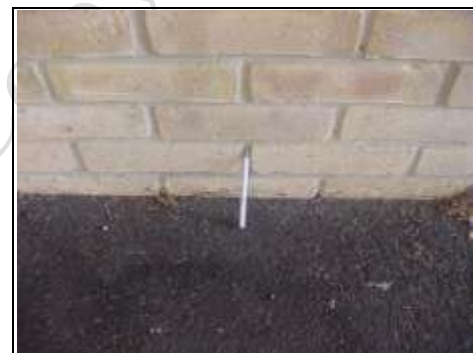
No DPC at all

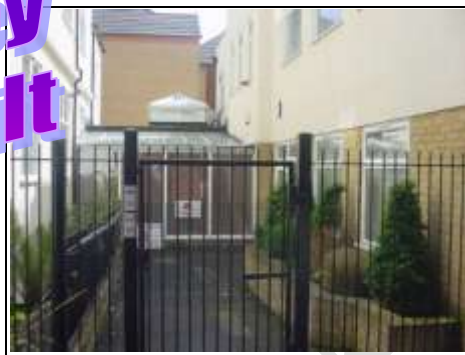
Rear side access to next door property – they have had drainage problems as the developer didn't increase the size of the original drains.

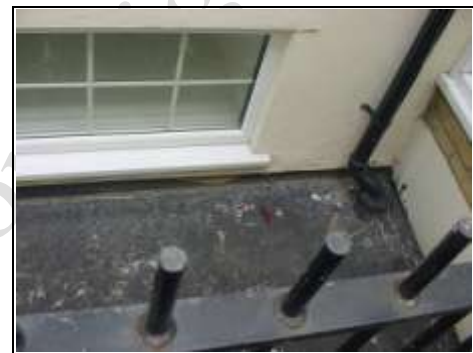
As mentioned, we have spoken to the occupiers in XXXXXXXX (they were the only ones in the property at the time of our inspection). They advised us of a major problem they have had with regard to sewerage and as they understand it the developer did not enlarge the drainage system when they carried out the development.

Sewerage problems have occurred in this area

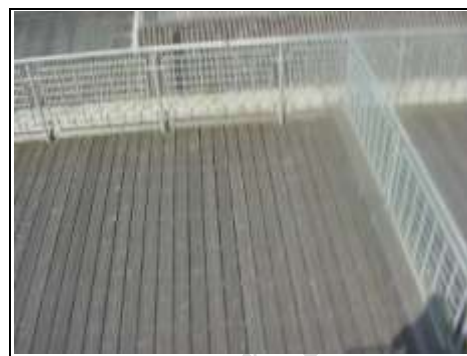
Your Legal Advisor needs to check if the roof terrace is considered an evacuation safe area. This means that people have the choice of going down the stairs to get away from the fire or up onto the roof to wait to be rescued. This may be why the roof is in an asphalt rather than a more combustible material. What concerns us is that you have a timber decking on the roof that may well be a fire area. We would much prefer to see a Pavia slab or similar, as you can see in the photo below.

Decking on top floor terrace

ACTION REQUIRED: We would recommend that the entirety of the decking is removed and a Pavia slab used which is more usual on an asphalt roof such as this.

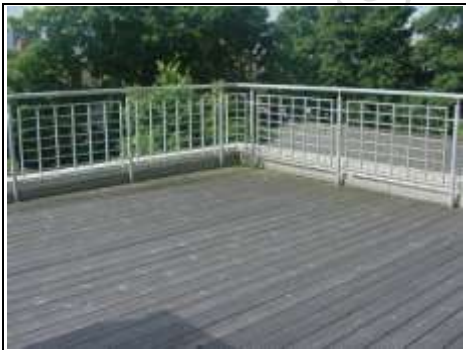
The main roof has a decking covering approximately 90% of the roof. Where we can see the roof it is asphalt, however we are concerned that we could see undulations in the asphalt where we could see it. Whilst we consider asphalt the Rolls Royce of roof finishes it does have to be put on by a skilled tradesman to an appropriate decking.

Decking

Our recommendation is to remove the decking, check the roof and add a Pavia slab to protect the roof.

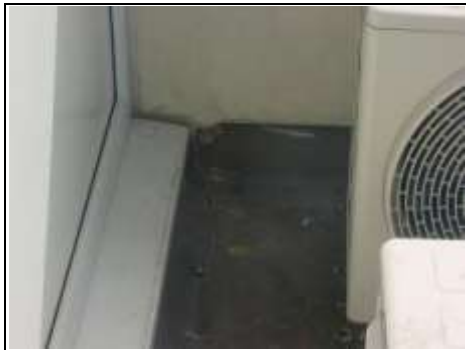
Crazing to the surface of the asphalt

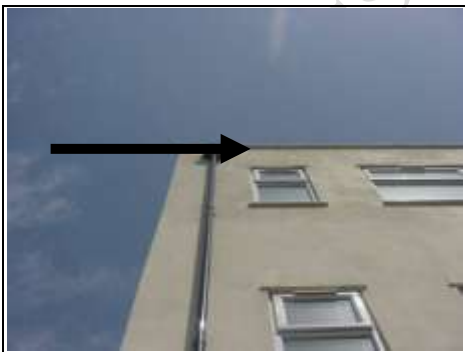
Our second concern is with regard to the parapet wall for a number of reasons, the coping stone which we have explained in more detail in the Executive Summary, the unusual weep hole details that we could see that we haven't come across previously in our many years of surveying and we could also see that the handrail is starting to rust.

Parapet wall depicted by arrow

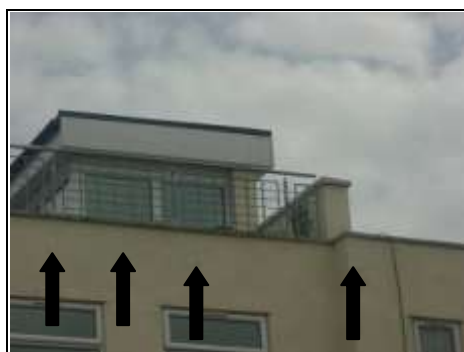
Weep holes in parapet wall

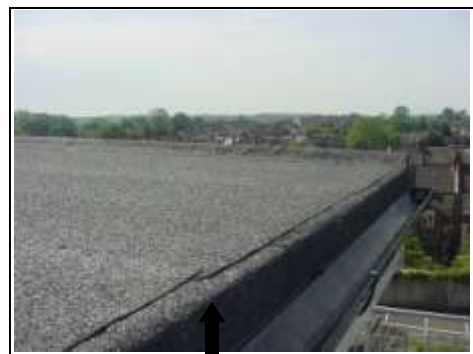
This is a felt flat roof. It is in slightly below average condition; we can see the cuts are uneven on the edge and the small upstand on this roof has not bonded correctly.

Looking at the felt roof itself, showing uneven cuts and rucking to upstand

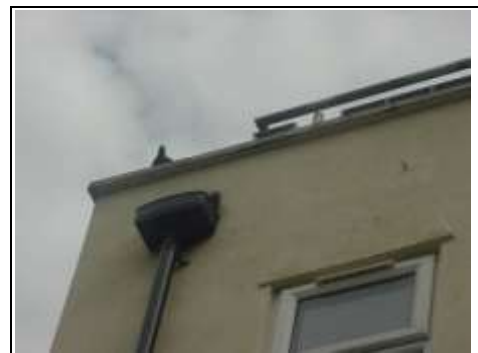
The main roof has one hopper head visible to the front of the property, we are hoping that it also has internal downpipes however we have not been able to see this. We would say that this is insufficient for the size of the roof and if it is the only outlet then it is likely to overflow. We believe that two downpipes on a roof of this size is the absolute minimum and we would be concerned with overflowing of the hopper head as well as blockages. We simply have no easy access underneath the decking to check this further.

Hopper head to front

ACTION REQUIRED: Add more downpipes; however this is far easier said than done.

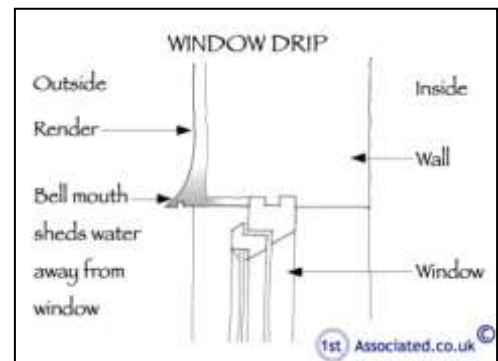
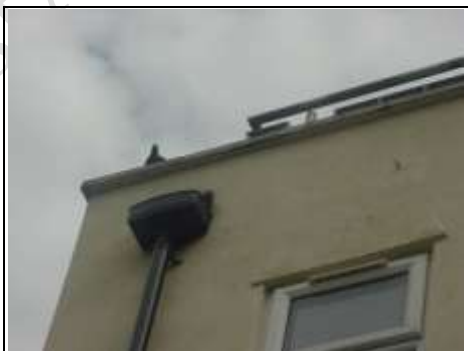
You can normally tell whether the render is good or not by the drip detail over the window and the bell mouth to the base of the property. There is a drip detail to all windows, although it is minimal in some cases.

Drip detail over window

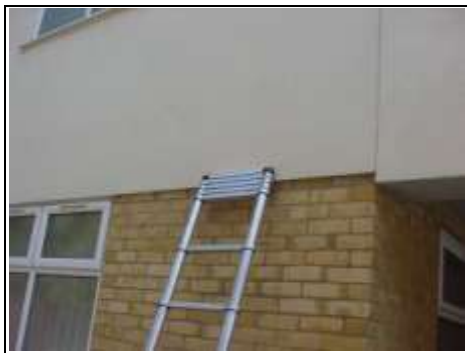
We would have preferred a larger drip detail to the base of the render.

Drip detail to base of render

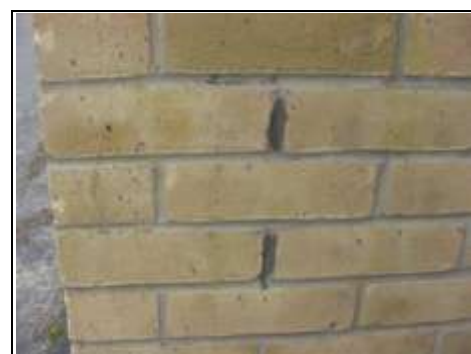
For some reason, which we are unable to establish, two areas of the brickwork have been repointed.

Two repointed perpendicular ends to the brickwork (perp ends)

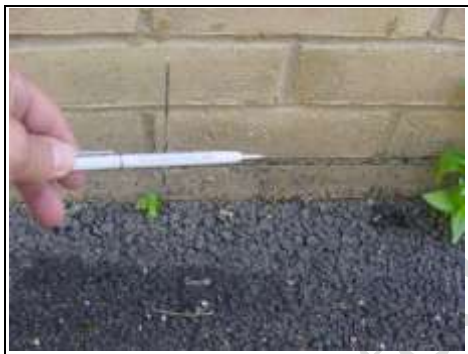
All modern properties should incorporate a damp proof course (DPC) and good building practice dictates that a differential of 150mm (6 inches) should be maintained between the damp proof course and ground levels. In this case, the DPC is intriguing. Where we can see it, it is too low and in some cases we cannot see it at all, which is a very poor practice on a modern property.

DPC too low

ACTION REQUIRED: We recommend a French drain is added around the property / lowering of the ground level. We would add that we have never come across this in a modern property previously.

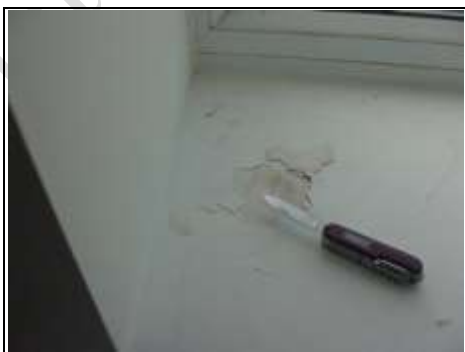
Flaking paint on window sills –
we saw condensation

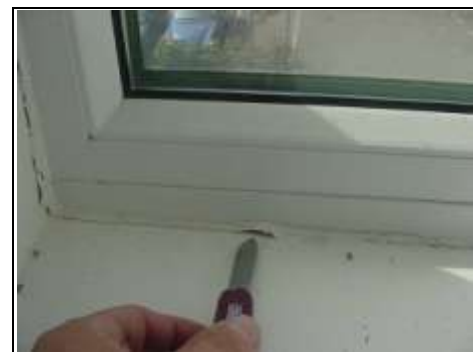
The property has plastic double glazed windows, which generally look to be of a reasonable quality. However having said that dampness can clearly be seen around a lot of them. We believe that possibly they have been positioned too far forward or without a damp proof course. Please see our earlier comments.

Dampness meaning that the mastic
around the windows is coming out

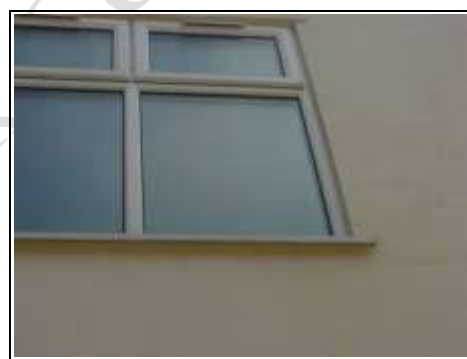
We noted opaque glass on the left hand side of the property (all directions given from the front entrance). This could mean that someone has rights to develop to the side of you.

Opaque double glazed window to left hand side

ACTION REQUIRED: Your solicitor to investigate. This may or may not be important or relevant to you. Please see our comments in the Executive Summary.

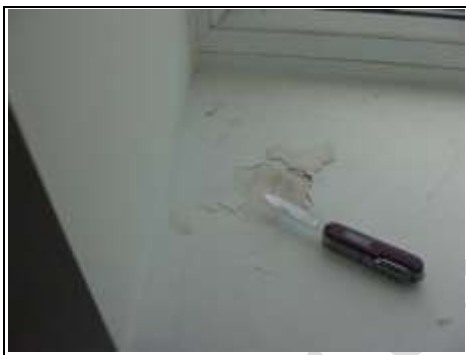
We used a damp meter on the external walls. We have found dampness.

Dampness to windows

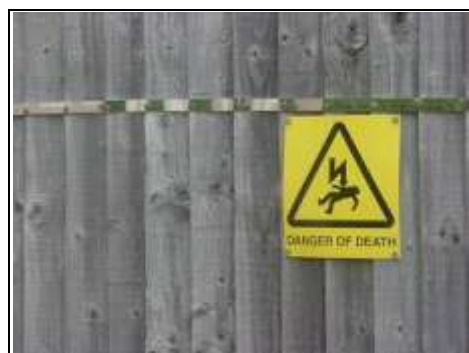
Please note there is an electricity substation close to the property. Concerns have recently been expressed with regard to health risks in connection with the above average electro-magnetic fields. Whilst health risks have not been proved some purchasers may be deterred.

Electricity substation close by
