SCHEDULE OF CONDITION

We have been instructed to inspect and prepare a Schedule of Condition for xxxxxxxxxxxx, W14 xxx. We inspected the property on 23rd May 2013.

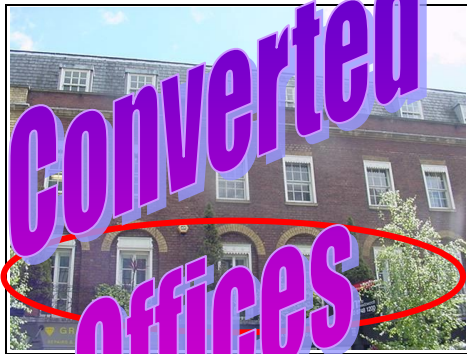
<p>External Detailing:</p> <p>Windows:</p> <p>Shop front at ground level entrance area</p> <p>Doors:</p> <p>Timber French doors (with aluminium doors internally) to first floor</p>	  <p>Slightly dated</p>   <p>Some doors not able to open at the time of our survey.</p>	<p>Repair, prepare and redecorate in the summer of 2014.</p> <p>Ease and adjust French timber doors giving access to balcony. Repair, prepare and redecorate in the summer of 2014.</p>
<p>Balcony area:</p>    	<p>Vegetation growth</p>    	<p>Remove vegetation and ensure that balcony is watertight.</p>

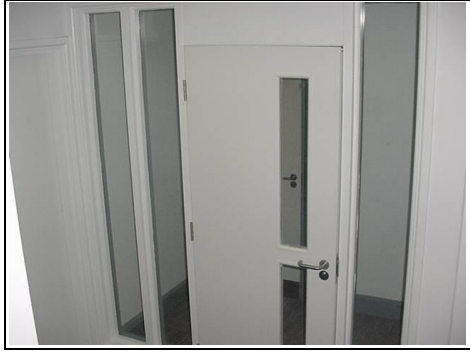
Door to lobby

DESCRIPTION	CONDITION	ACTION REQUIRED
Ceilings: Suspended ceiling system with exposed grid Two lights	Average	
Walls: Painted	Dated	Clean and possibly redecorate
Floors: Suspended metal floor with carpet	Dated	Clean

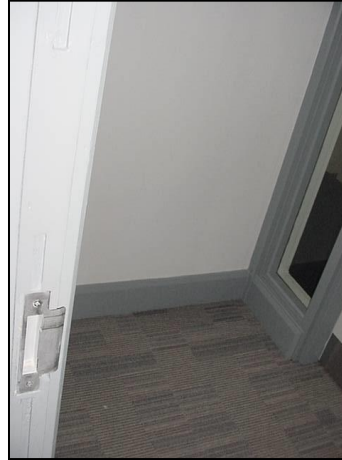
Lobby

<p>Detailing:</p> <p>Internal Windows to either side of door: Glazed units, two to left, one to right</p> <p>Internal Door Central: Two vision panels</p> <p>Skirting: Grey 150mm skirting running around the perimeter,</p>	<div data-bbox="719 188 954 365"></div> <p>Dated with some paint on window</p> <div data-bbox="719 434 954 611"></div> <p>Dated</p> <p>Dated</p>	<p>Remove paint from windows. Repair, prepare and redecorate.</p> <p>Repair, prepare and redecorate.</p> <p>Repair, prepare and redecorate.</p>
--	--	---

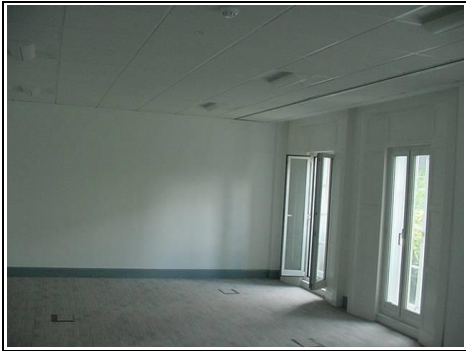
Front towards French doors

DESCRIPTION	CONDITION	ACTION REQUIRED
Ceilings: Suspended ceiling system with exposed grid

Replace marked/damaged tiles with equivalent tiles.
Staining Kitchenette area:	Leak from above to kitchenette area

Resolve leak. Replace tiles.

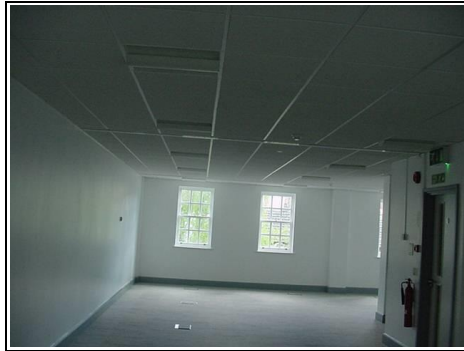
Open plan office

Walls: Painted	Dated	Clean. Repair, prepare and redecorate.
Floor Structure: Suspended floor metal with carpet finish Floors:

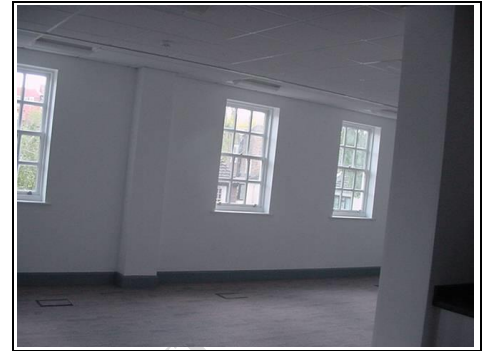
Rear

<p>Detailing:</p> <p>French Doors/Windows:</p> <p>Timber single glazed French door externally with internal double glazed windows.</p> <p>French doors externally</p> <p>Aluminium double glazed door internally</p> <p>Rear sliding sash windows</p> <p>Four modern timber sliding sash windows with double glazing</p>   <p>Architraves around doors:</p> <p>Grey</p> <p>Skirting:</p> <p>Grey 150mm skirting running around the perimeter</p>	<p>Difficult to open</p>     <p>Difficult to open.</p>     <p>Dated</p>	<p>Ease and adjust, repair, prepare and redecorate in the summer of 2014 and leave in working order.</p> <p>Clean</p> <p>Ease and adjust, repair, prepare and redecorate in the summer of 2014 and leave in working order.</p>
---	---	--

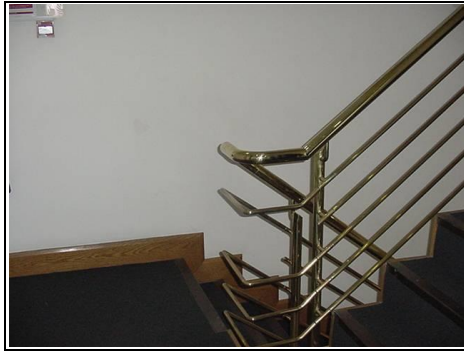
Staircase

DESCRIPTION	CONDITION	ACTION REQUIRED
Ceilings: Suspended ceiling system with exposed grid		
Walls: Paint	Dated and marked	Repair, prepare and redecorate.
Floors: Concrete carpeted with a nosing Carpet		Deep clean
Detailing: Handrail: Brass Skirting:	Marked

Repair, prepare and redecorate.

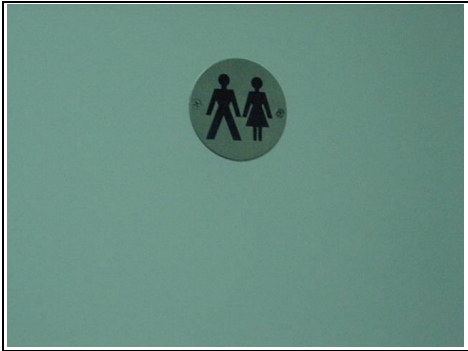
Unisex

DESCRIPTION	CONDITION	ACTION REQUIRED
Ceiling: Suspended ceiling system with exposed grid Two lights		
Walls: Fully tiled Formica panelling to W.C. side Formica access panels to ductwork (assumed)	Some areas marked
