# PROPERTY REPORT AND NEGOTIATION DOCUMENT

xxxxxxxxxx,  
xxxxxxxxxxxxxx,  
xxxxxxxxxx,  
Southampton,  
Hampshire,  
xxxxxxx

INDEPENDENT CHARTERED SURVEYORS

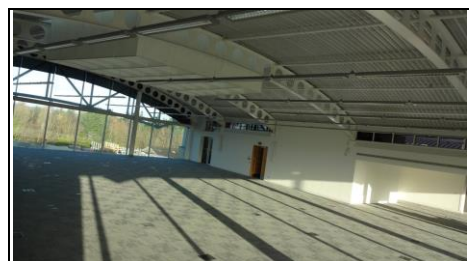
General view of internal of right domed roof

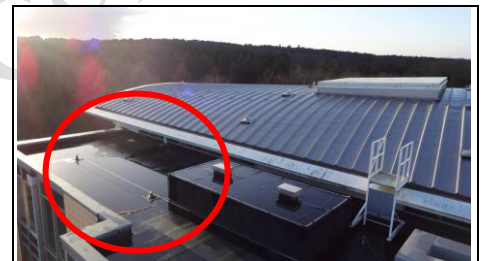
This is where water sits on the roof and in this case we can also see it is coming through the roof.

Ponding to right flat roof

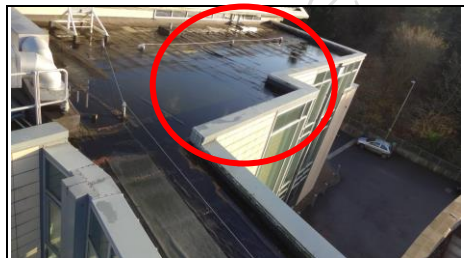
Ponding to mono-ply roof

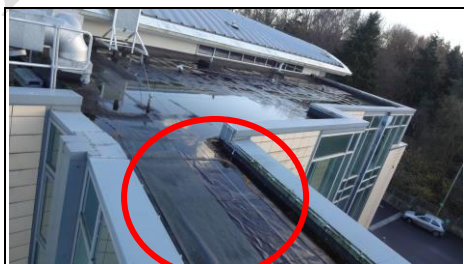
Rucking and ponding on mono-ply roof

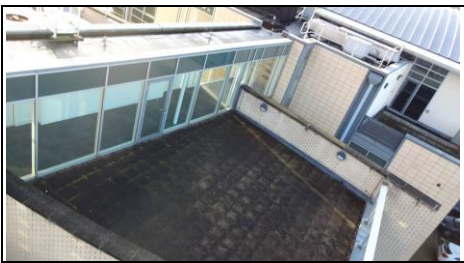
Inverted roof above the reception area

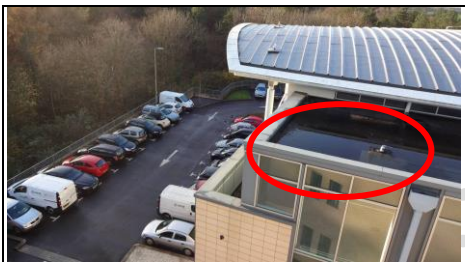
Metal coping over rain cladding with water sitting on it

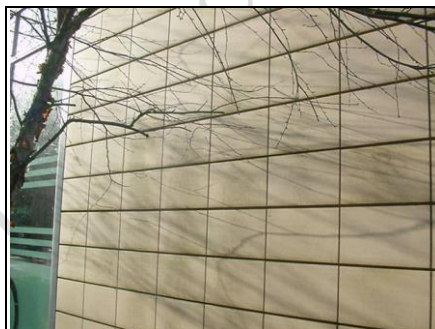
Large areas of the property have a rain cladding system. Again, moss and lichens are starting to discolour this area.

Moss and lichens to rain cladding on left gable end

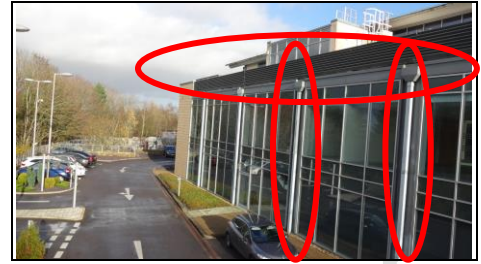
There are profile metal sheets at high level and also a vent type system. In the case of the main profile metal sheets they are starting to degrade, we could see some joints starting to open up and there is general weathering to the metal. We were not sure whether this metalwork has been sprayed before or cleaned; certainly something has happened to it. This is noticeable in particular behind where the downpipes are, the weathering of the profile metal sheeting.

Profile metal sheets and vents

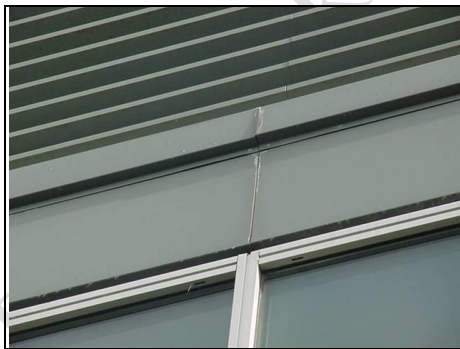
Weathering to joint

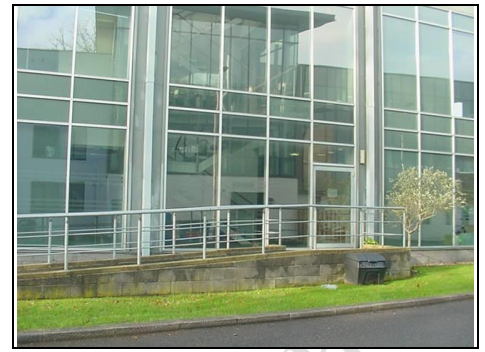
Glazed curtain walling

The glazed curtain walling is in a below average condition. We could see some of the transoms and mullions had become displaced as well as moss on the sills and them generally requiring cleaning.

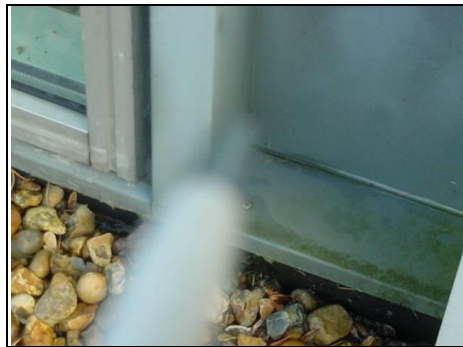
Moss on sill

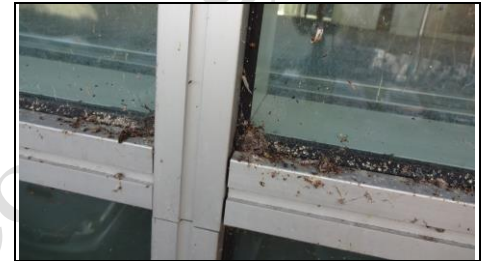
Dirty

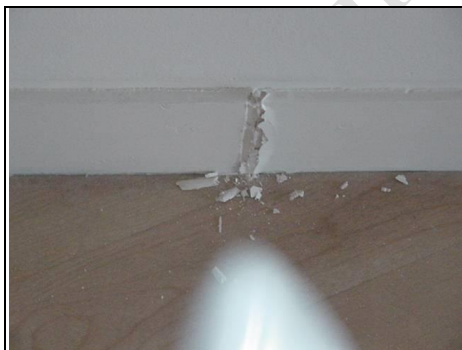
Dampness in skirting of restaurant

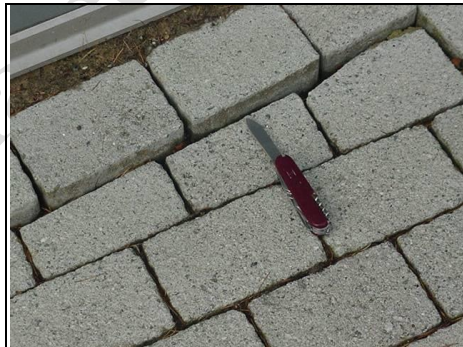
Unevenness in external cobbles
